**PRELIMINARY AND DETAILED
SITE CONTAMINATION INVESTIGATION REPORT**

HORNBY LIGHTHOUSE, WATSONS BAY NSW 2030

PREPARED FOR THE
PORT AUTHORITY OF NEW SOUTH WALES
REPORT ID: E24017WB-R01F

Date: 3rd December 2024

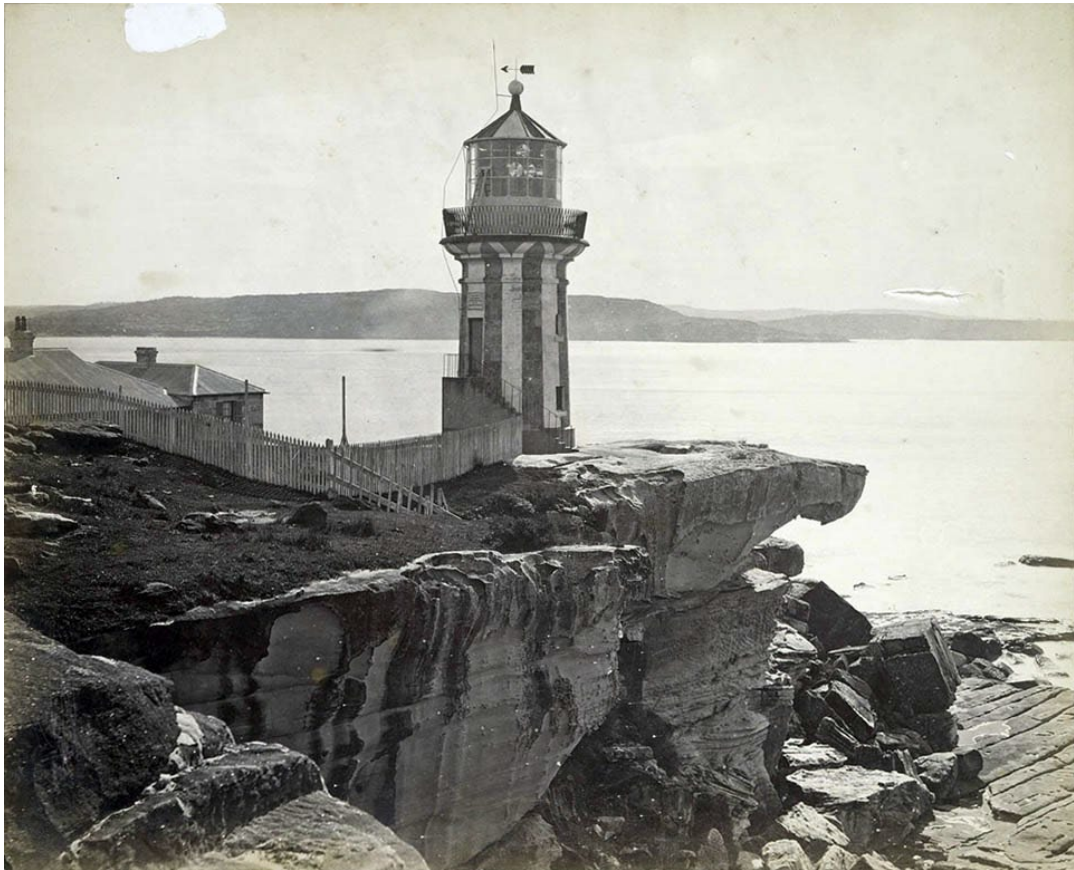
Plate 3 – Photograph dated c1880 (Source: Dictionary of Sydney, State Library of NSW).

The above photograph was taken approximately 20 years after Hornby Lighthouse was constructed. Fencing that wasn't observed in the historical aerial photographs can be seen in this image. The house immediately to the west of the lighthouse which is still present today can be seen in this image.

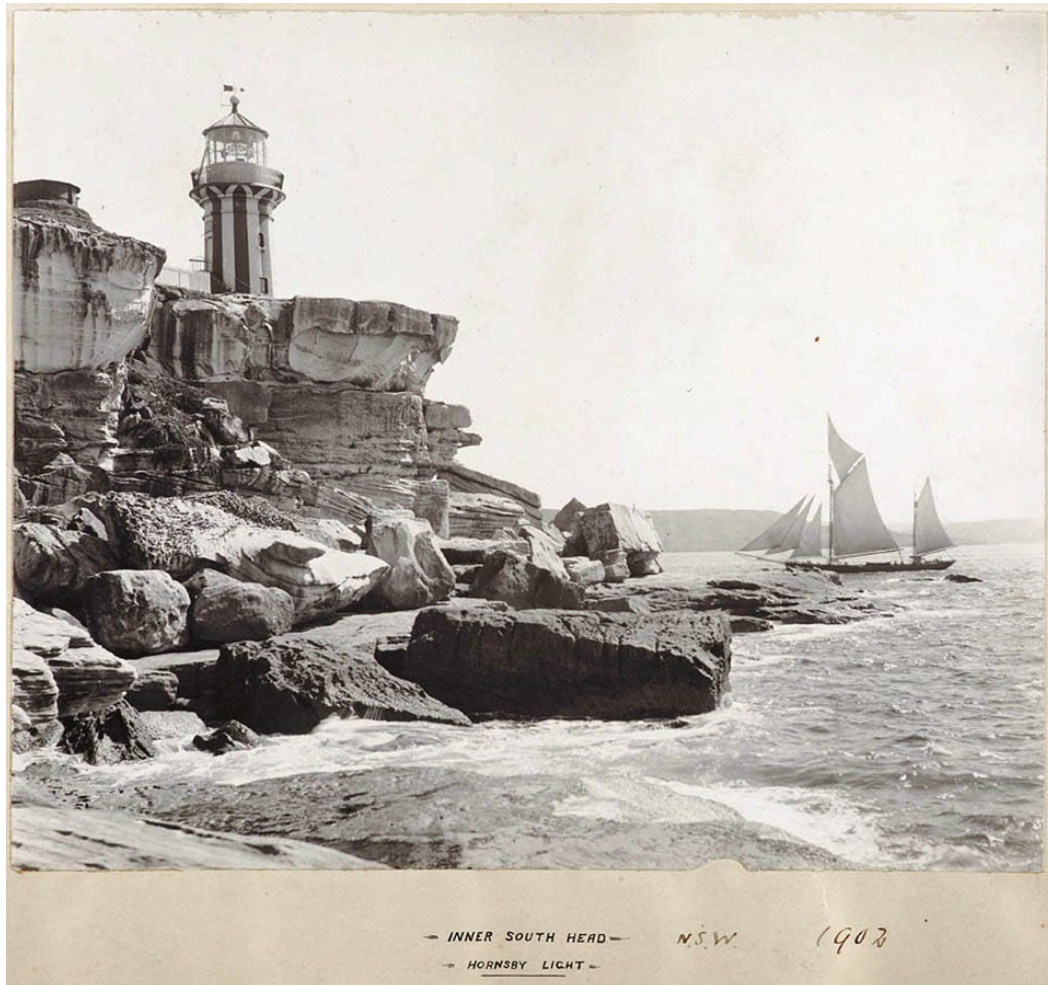
Plate 4 – Photograph dated 1902 (Source: Dictionary of Sydney, State Library of NSW).

The above photograph is another early photograph of Hornby Lighthouse, taken from further away showing more of the southern part of the cliff line. The nearby circular fortification (gun emplacement) pits (still present today) can be seen in this image.

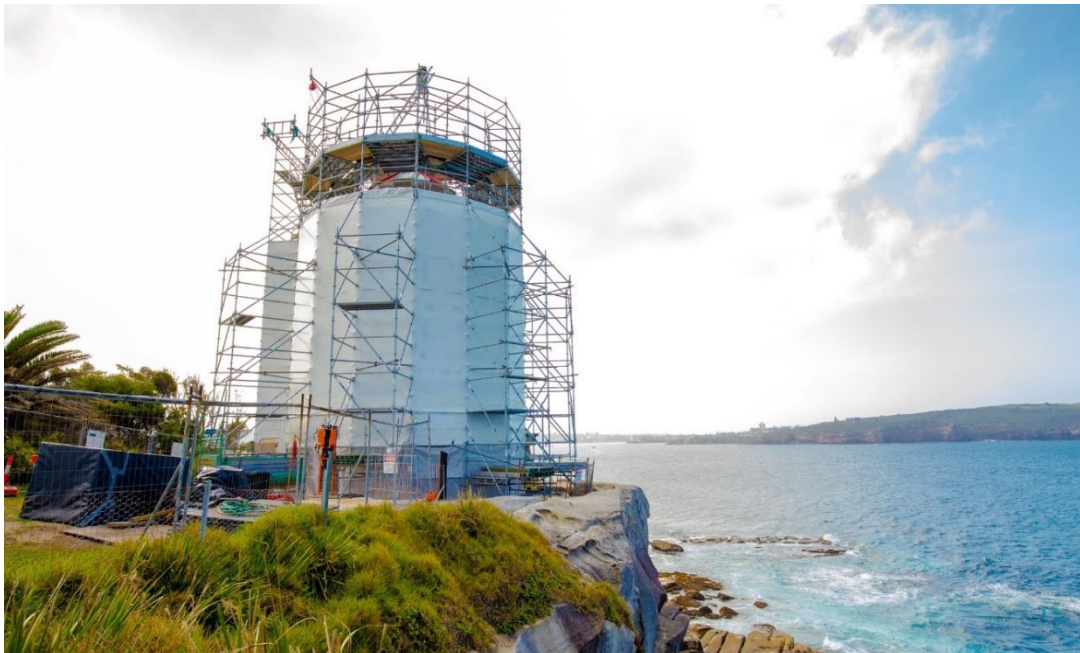
Plate 8 – Photograph dated 2024 (Source: Facebook Page of Bayside Scaffolding Services).

The above photograph from 2024 shows the scaffolding that was erected around the lighthouse to assist with the recent refurbishment works.

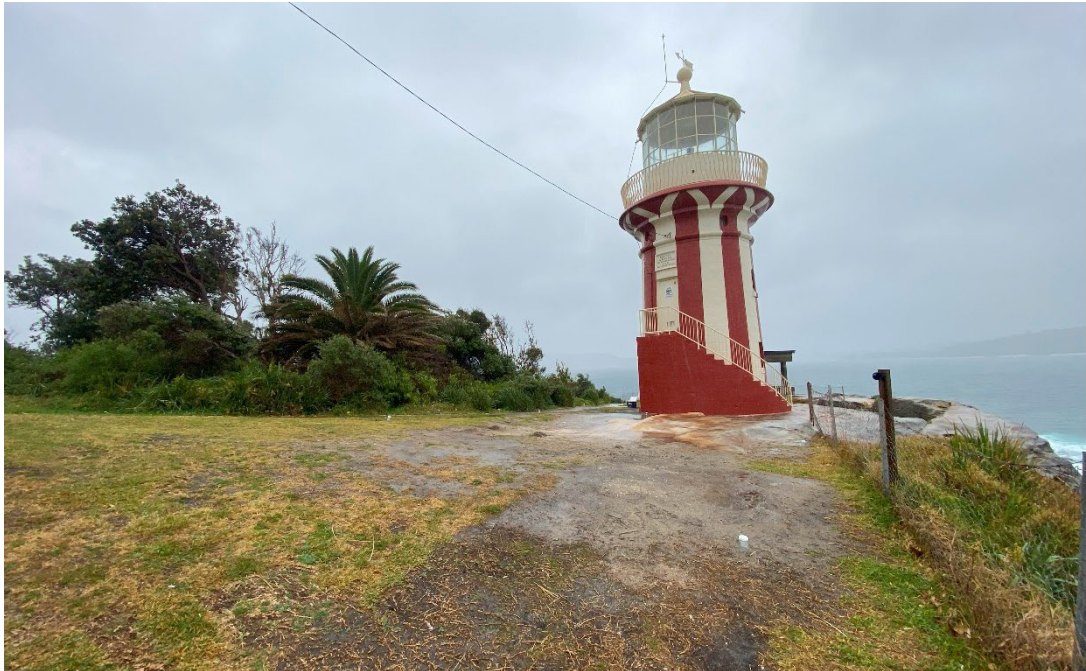
Plate 10 – View towards the north showing the lighthouse (post-refurbishment) and general area south and west of the lighthouse.

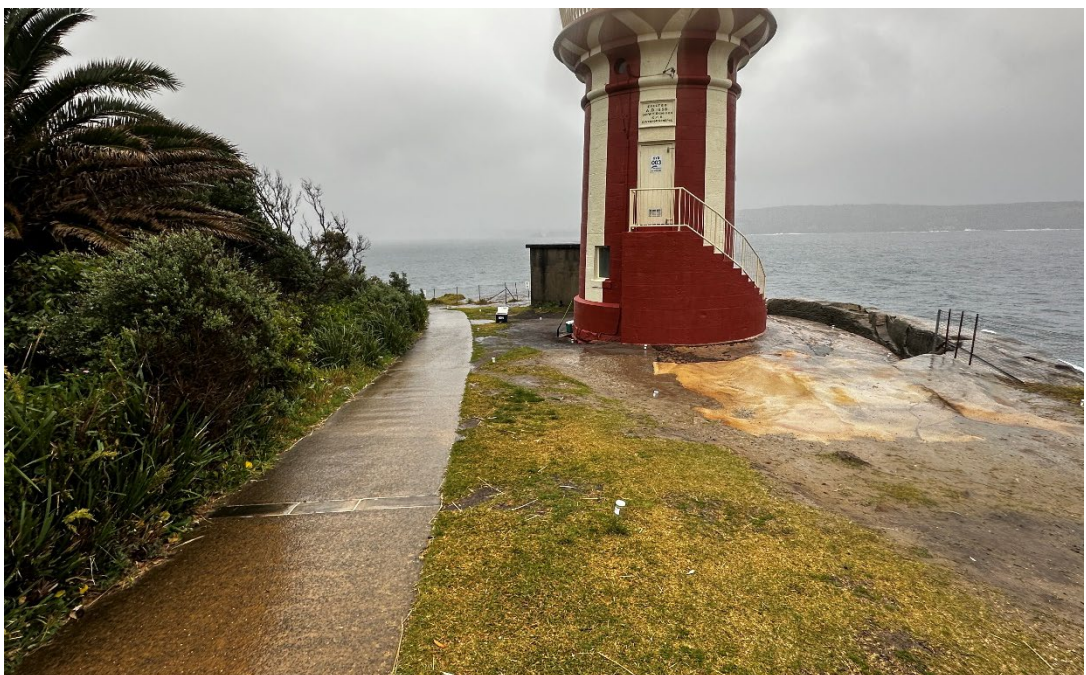
Plate 11 – View towards the north, showing the lighthouse, concrete pavement, and garden bed.

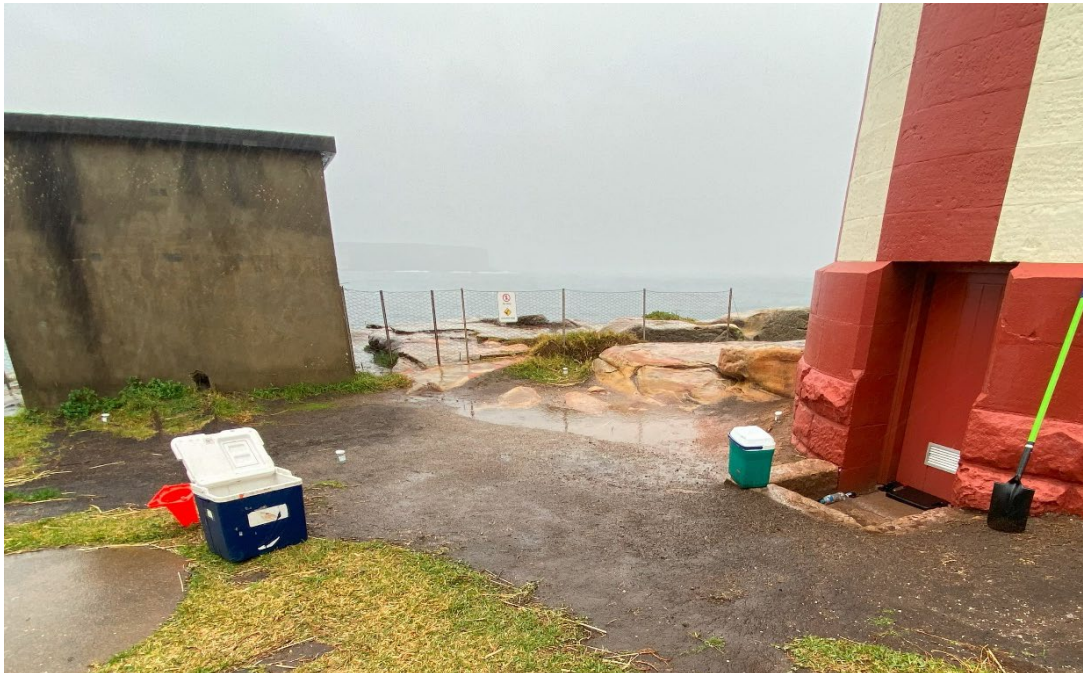
Plate 12 – View towards the north-east, showing the rocky outcrops on the northern side of the lighthouse.

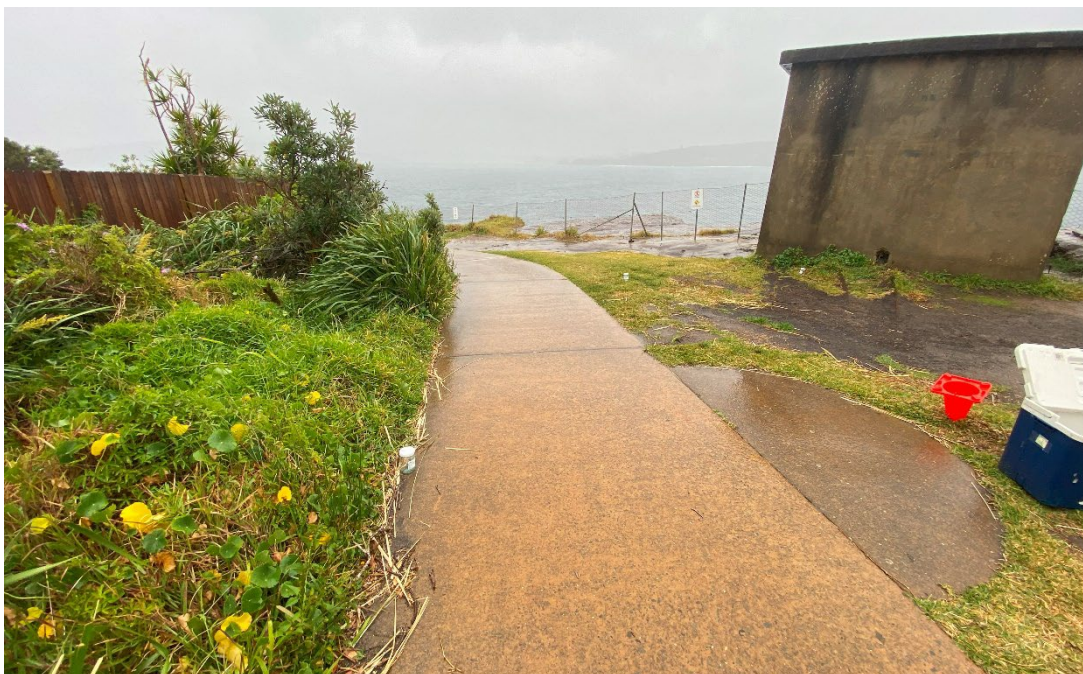
Plate 13 – View towards the north along South Head Heritage Trail, showing the concrete structure and garden beds to the west.

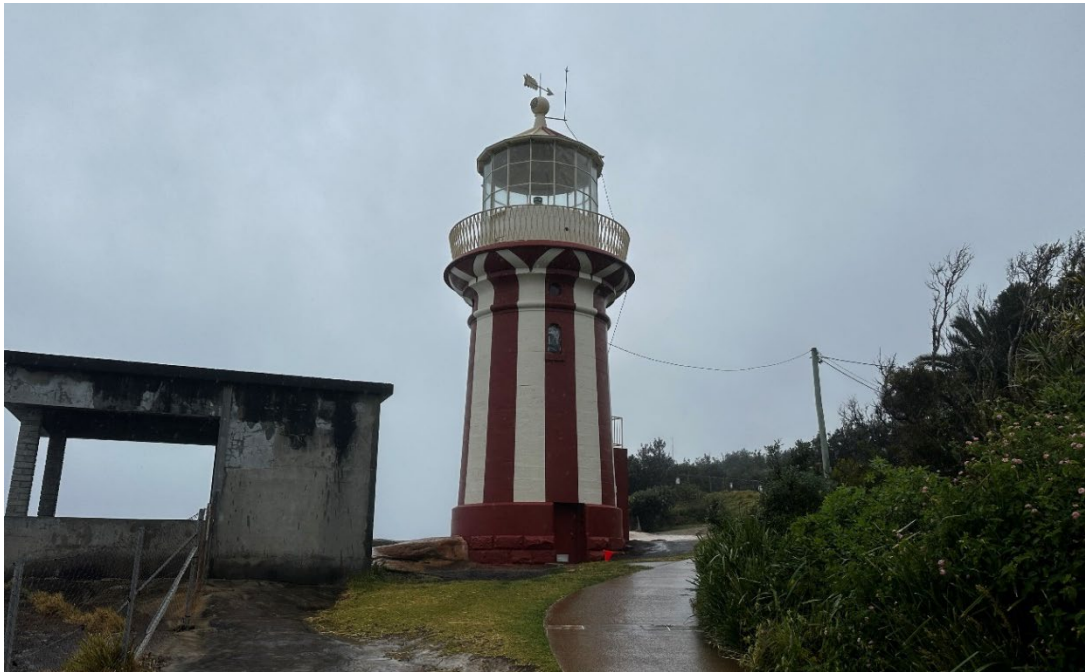
Plate 14 – View towards the south-east, showing the lighthouse, concrete structure, garden beds and the pavement.

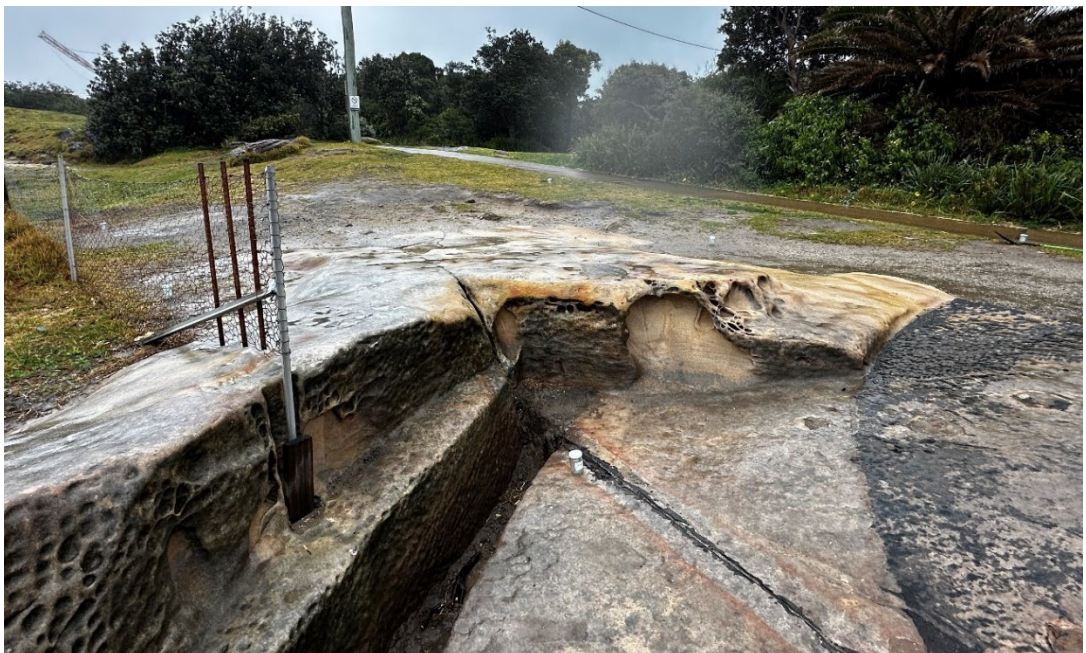
Plate 15 – View towards the south-west, showing the rocky outcrop and sandstone wall immediately surrounding the lighthouse, and the gentle upward slope towards the south of the lighthouse.

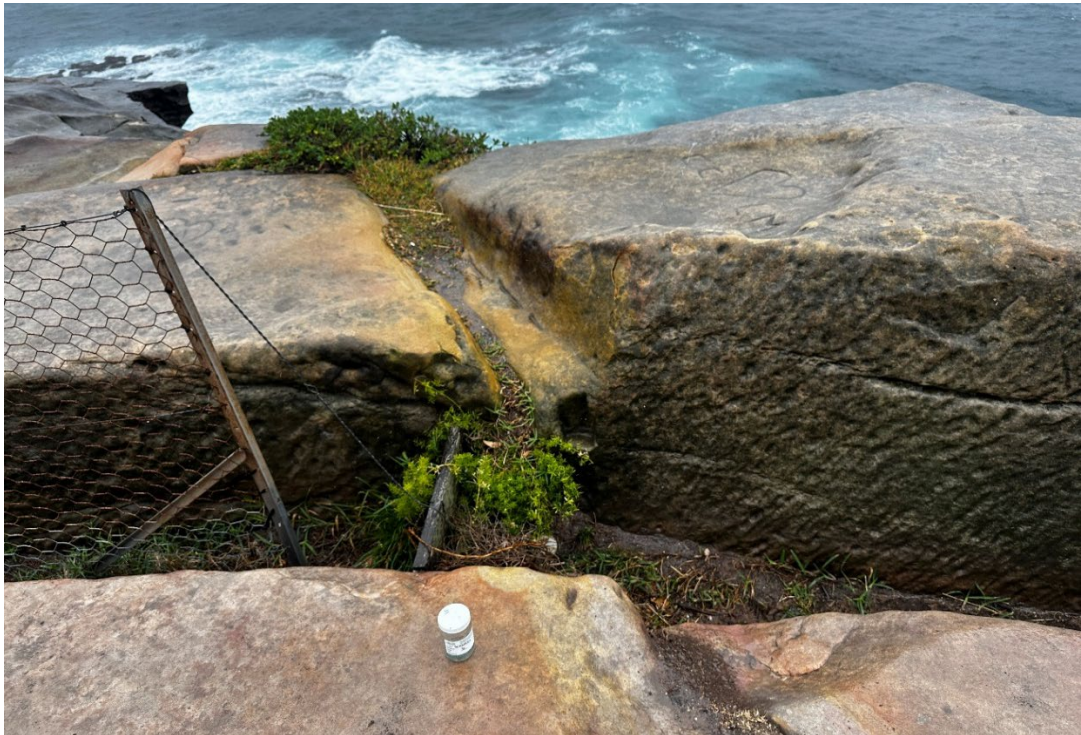
Plate 16 – View of the sandstone wall surrounding the lighthouse, showing the soils within the crevices.

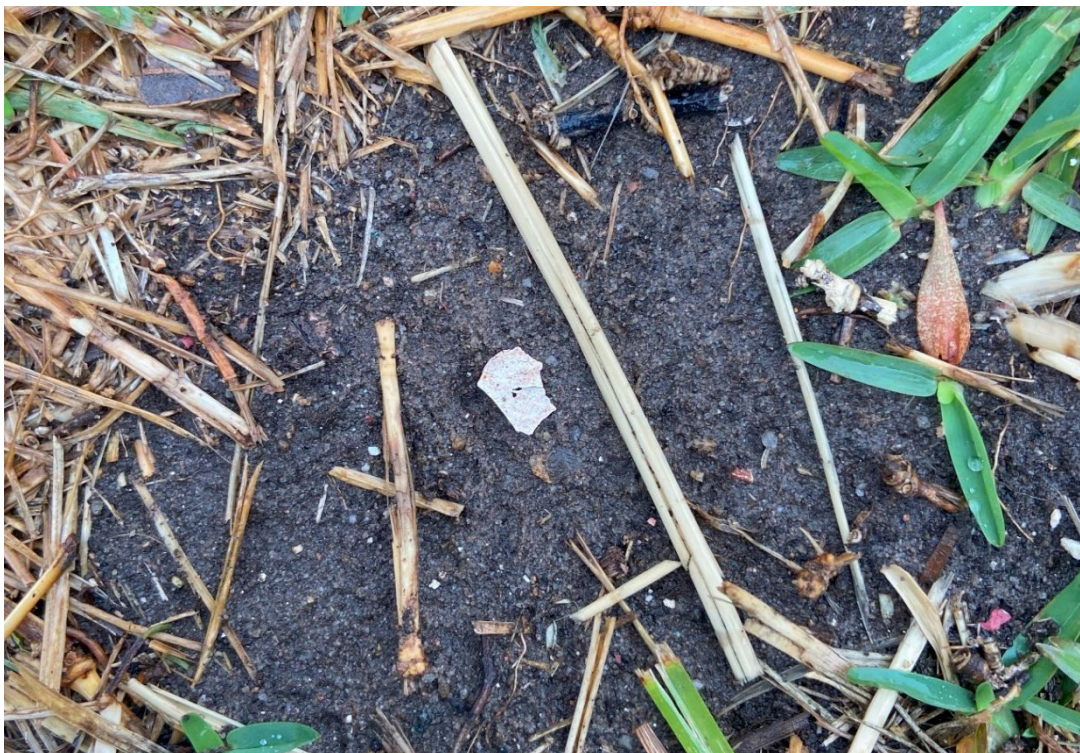
Plate 17 – Example of a white paint fleck observed on the exposed surface soils.

During sampling, the soil profile was geologically logged by an environmental scientist and/or geotechnical engineer, taking care to describe the presence and depth of anthropogenic inclusions and adverse aesthetics such as discolouration, odours or obvious evidence of contamination. There was no adverse odour or staining observed during sampling, and no other obvious indicators of contamination such as ACM. However, there was sporadic evidence of paint flecks observed on the surface in parts of the site (refer to Plate 17 above for an example). Following sampling, the testpits were backfilled.

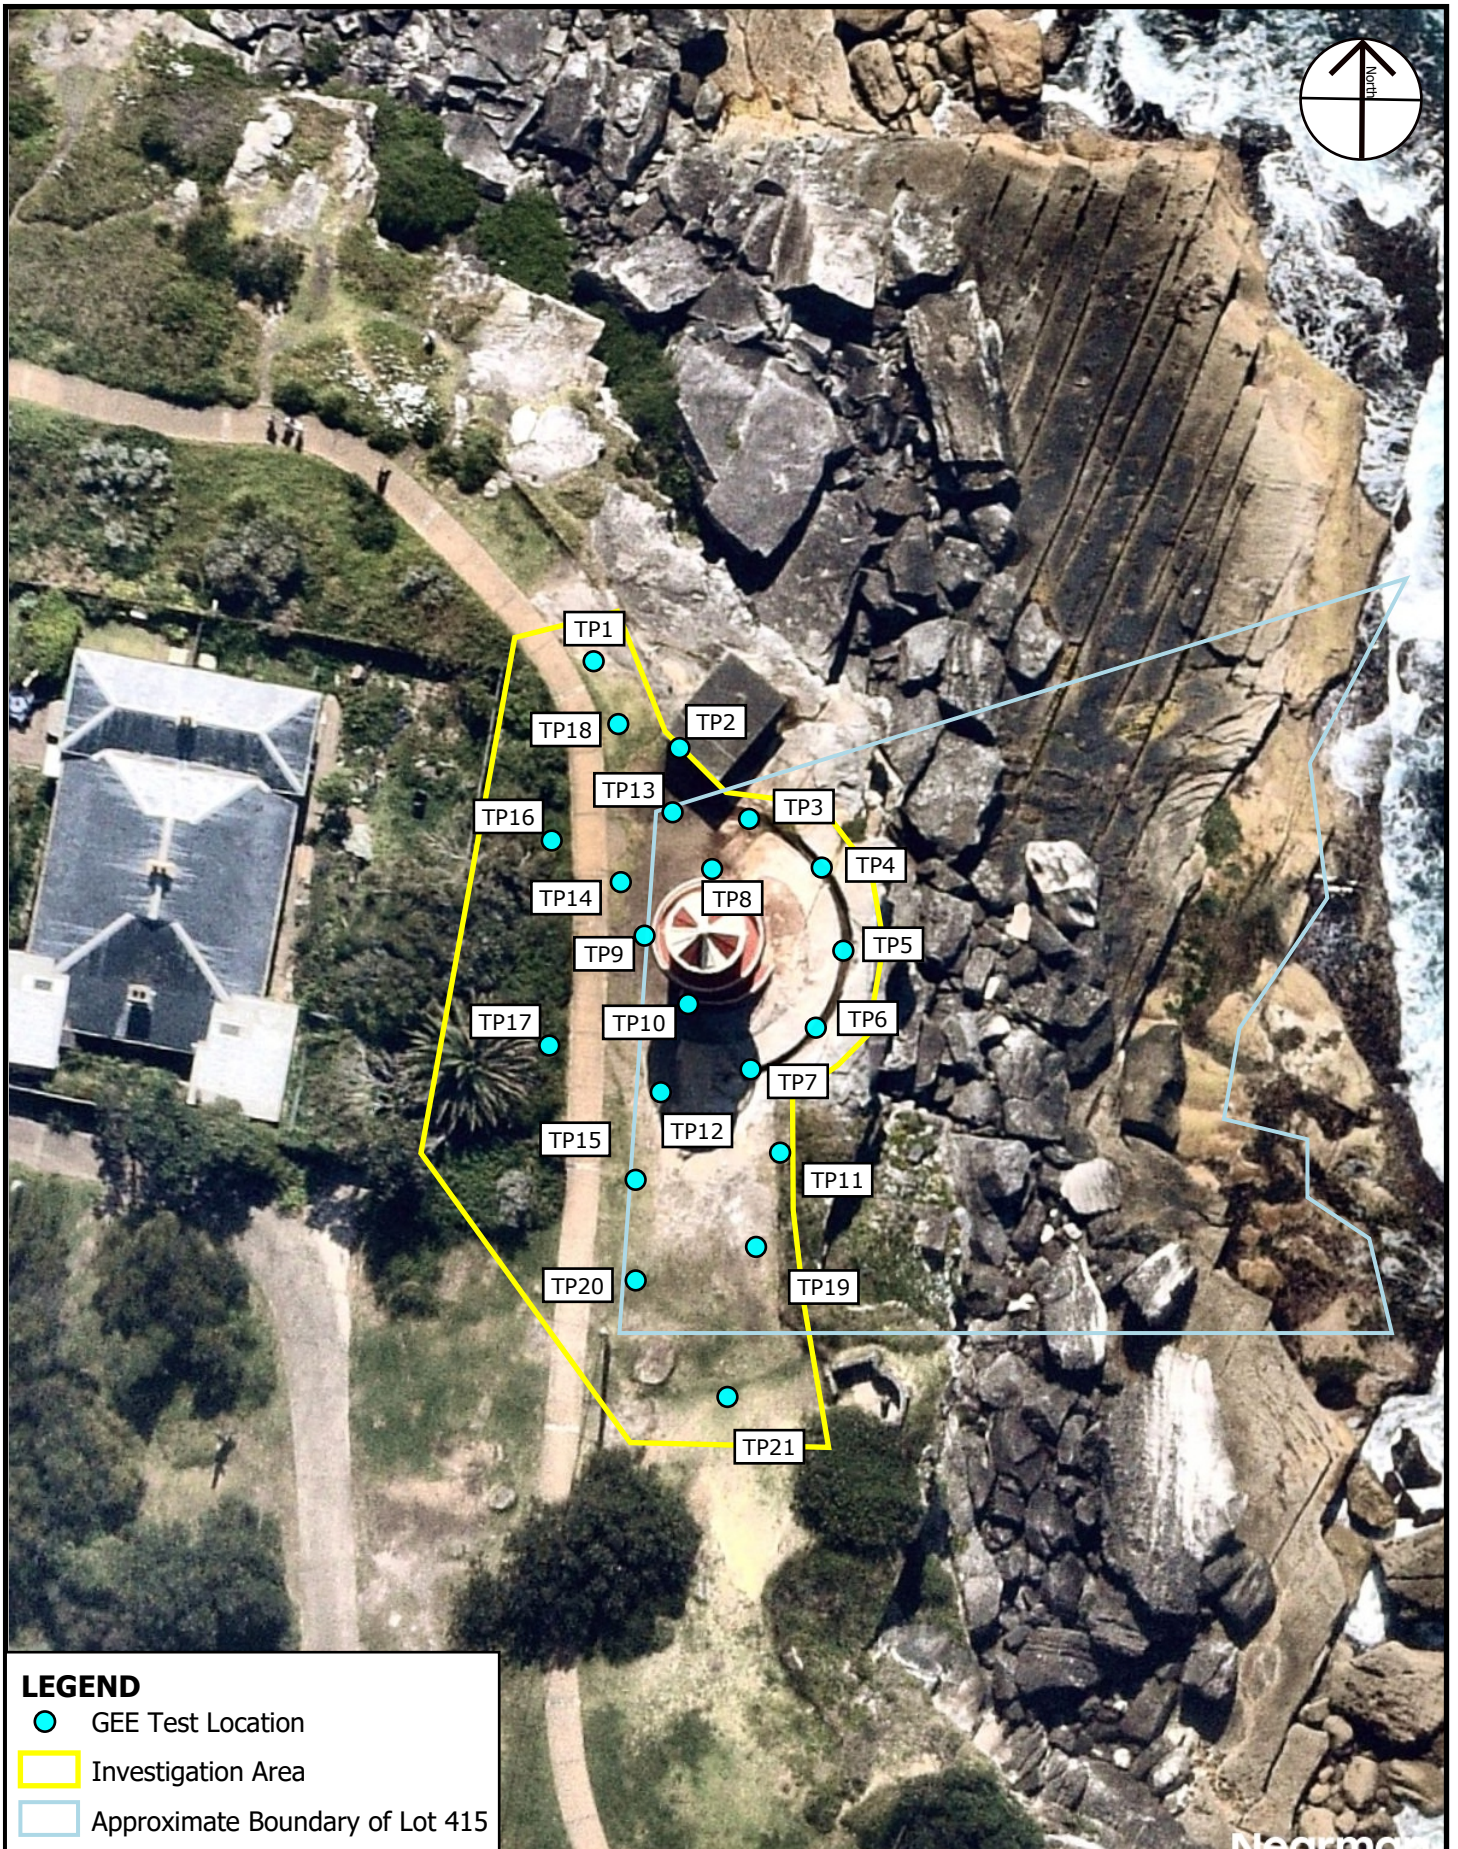
FIGURE No.: **1**
 REVISION: **A**

A summary of the subsurface conditions encountered is provided in Section 6.1.2, while the locations of the testpits are shown on **Figure 2** along with a recent aerial photograph.

Soil conditions across the site were assessed at twenty-one testpit locations (**Figure 2**) positioned in accessible locations across the site. The number of testpits exceeds the minimum number of sampling points required for adequate site characterisation as defined by the EPA NSW (reference 9).

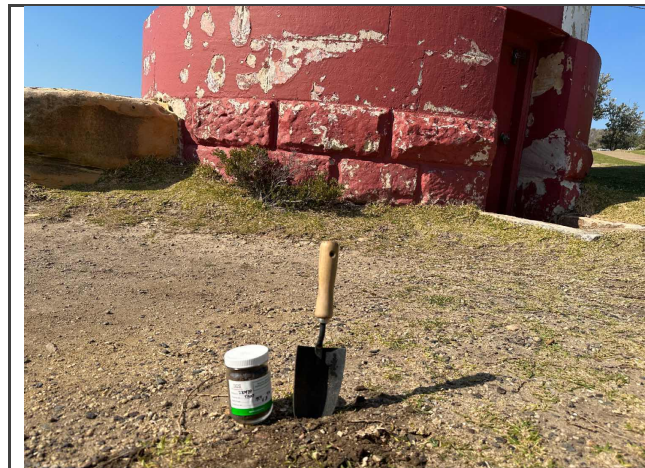
PHOTO: 2	LOCATION: External, GF Perimeter North of lighthouse
MATERIAL: Soil (heavy metal contaminants)	RESULT: Refer to Sampling Register

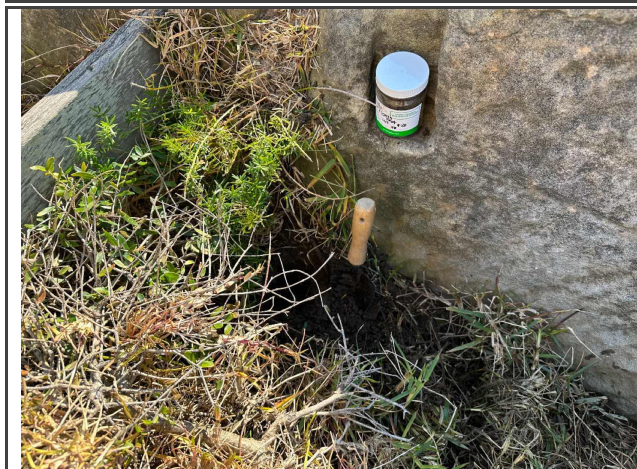
PHOTO: 3	LOCATION: External, GF Perimeter North-east of the lighthouse - within the run off
MATERIAL: Soil (heavy metal contaminants)	RESULT: Refer to Sampling Register

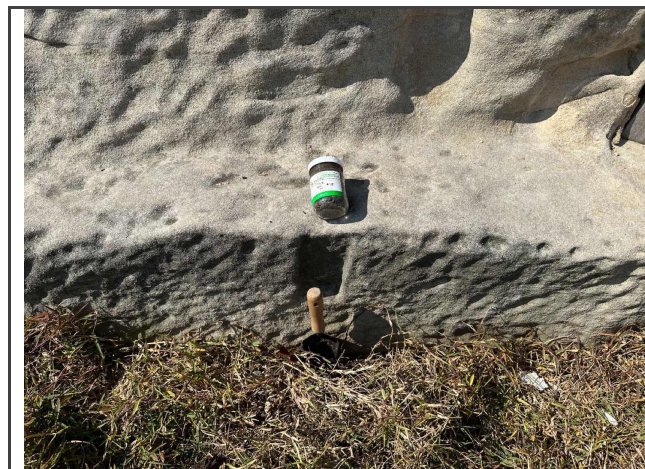
PHOTO: 4	LOCATION: External, GF Perimeter South east of the lighthouse - within the run off
MATERIAL: Soil (heavy metal contaminants)	RESULT: Refer to Sampling Register

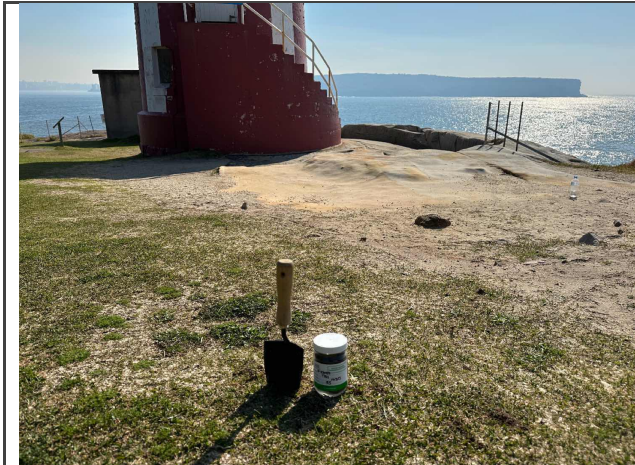
PHOTO: 5

LOCATION: External, GF Perimeter
South of lighthouse

MATERIAL: Soil
(heavy metal
contaminants)

RESULT: Refer to Sampling Register

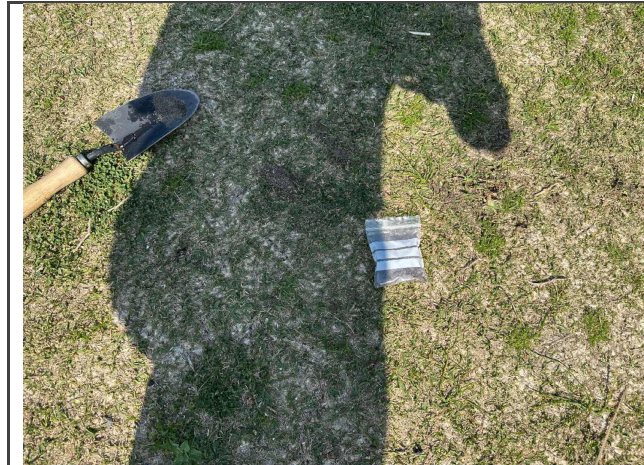
PHOTO: 6

LOCATION: External, GF Perimeter
TP01 - South of the lighthouse

MATERIAL: Soil
(asbestos)

RESULT: NADRL,ORG

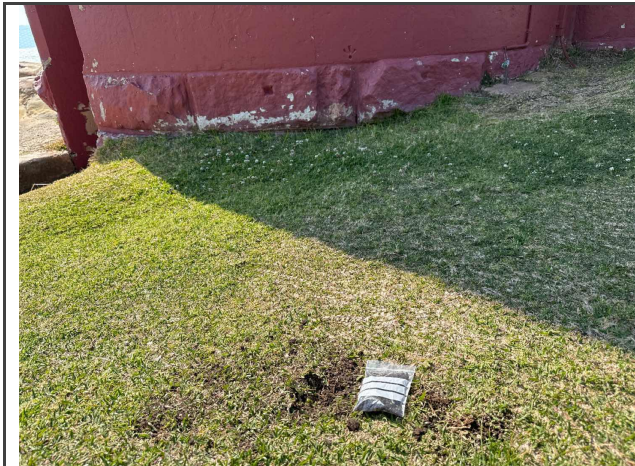
PHOTO: 7

LOCATION: External, GF Perimeter
TP02 - West of the lighthouse

MATERIAL: Soil
(asbestos)

RESULT: NADRL,ORG

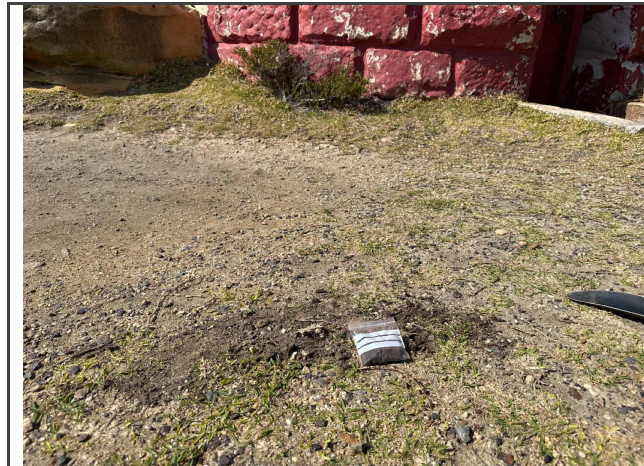
PHOTO: 8

LOCATION: External, GF Perimeter
TP03 - North of the lighthouse

MATERIAL: Soil
(asbestos)

RESULT: NADRL,ORG

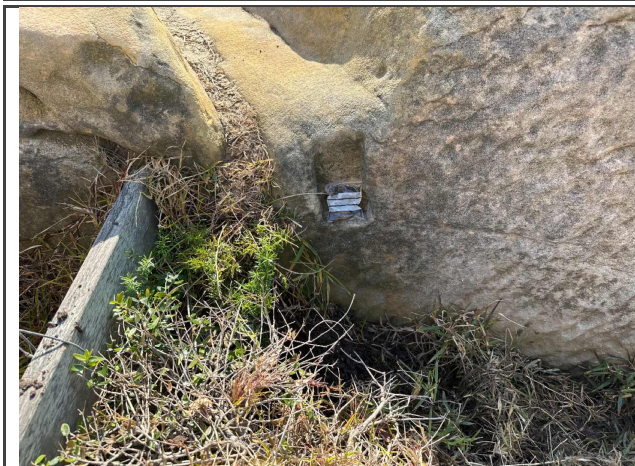
PHOTO: 9

LOCATION: External, GF Perimeter
TP04 - North east of the lighthouse

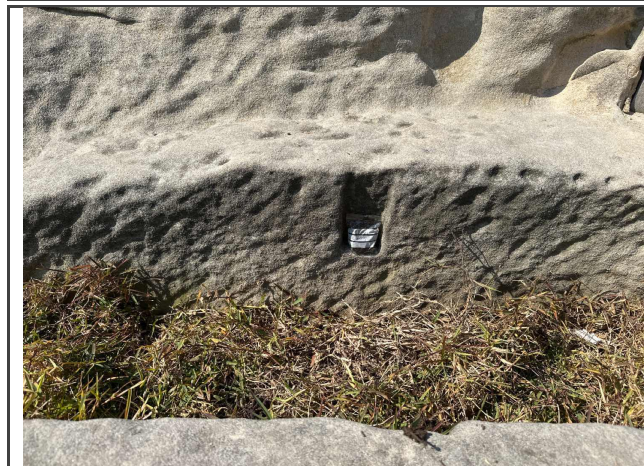
PHOTO: 10

LOCATION: External, GF Perimeter
TP05 - South east of the lighthouse

MATERIAL: Soil (asbestos)	RESULT: NADRL,ORG

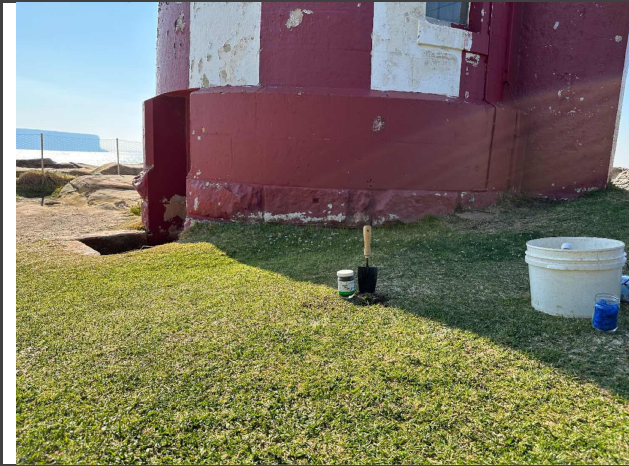
PHOTO: 11	LOCATION: External, GF Perimeter West of lighthouse
MATERIAL: Soil (heavy metal contaminants)	RESULT: Refer to Sampling Register

MATERIAL: Soil (asbestos)	RESULT: NADRL,ORG

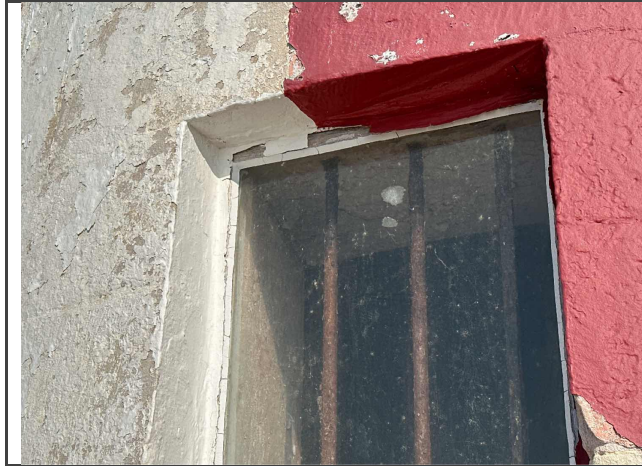
PHOTO: 12	LOCATION: External, GF Perimeter Window frames - between the glass and timber
MATERIAL: Putty	RESULT: NAD,ORG

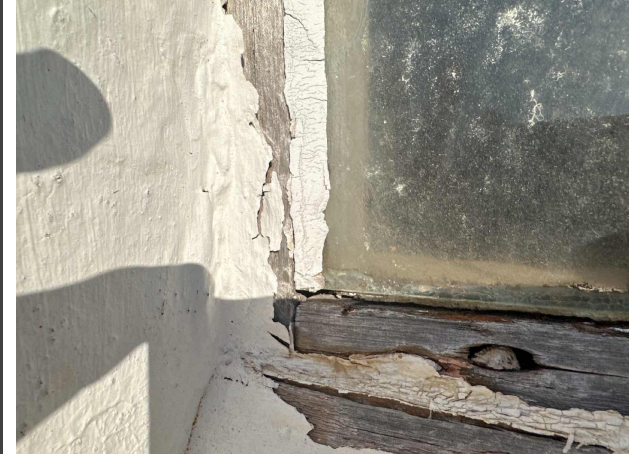
PHOTO: 12.1	LOCATION: External, GF Perimeter Window frames - between the glass and timber
MATERIAL: Putty	RESULT: NAD,ORG

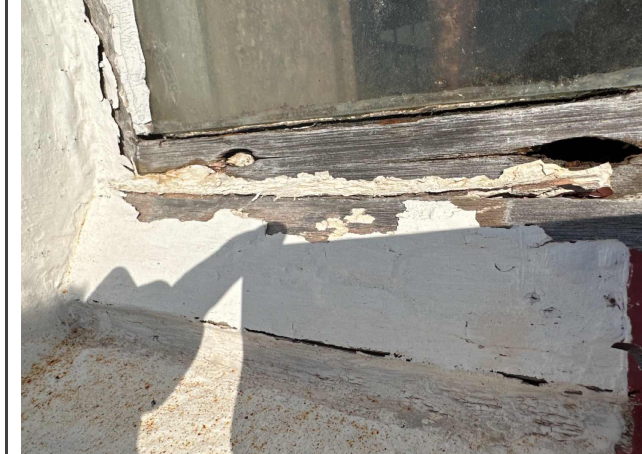
PHOTO: 13	LOCATION: External, GF Perimeter Window frames - between the timber framework
MATERIAL: Putty	RESULT: NAD,ORG

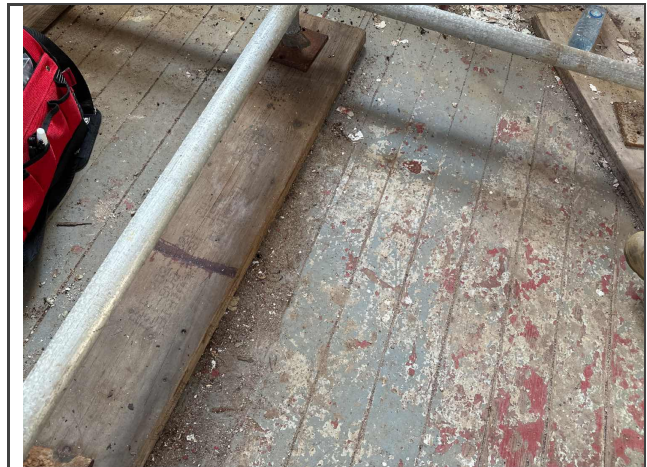
PHOTO: 17	LOCATION: Internal, GF Entrance Timber floorboards
MATERIAL: Undercoat - Red - Various Topcoats	RESULT: Refer to Sampling Register

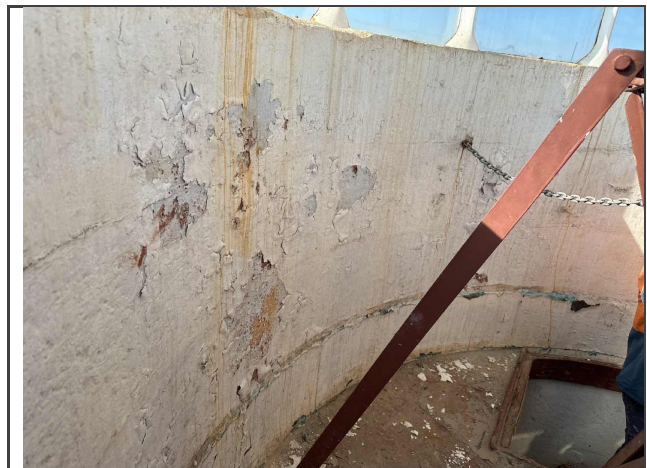
PHOTO: 19	LOCATION: Internal, L2 Lantern room Mortar lines
MATERIAL: Mortar	RESULT: NAD,ORG

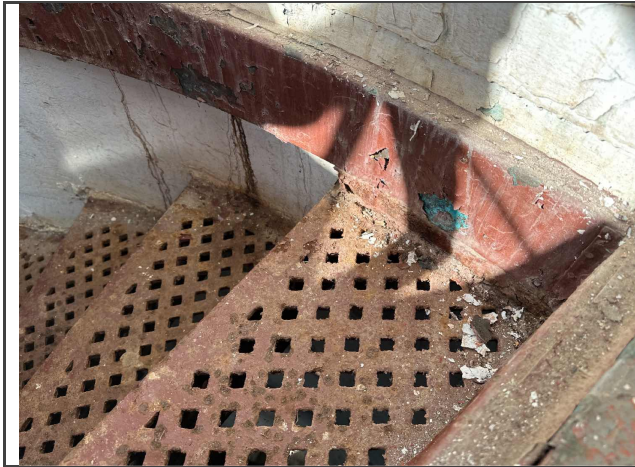
PHOTO: 20	LOCATION: Internal, L2 Lantern room Stairs, handrails & lantern framework
MATERIAL: Topcoat - Brown	RESULT: Refer to Sampling Register

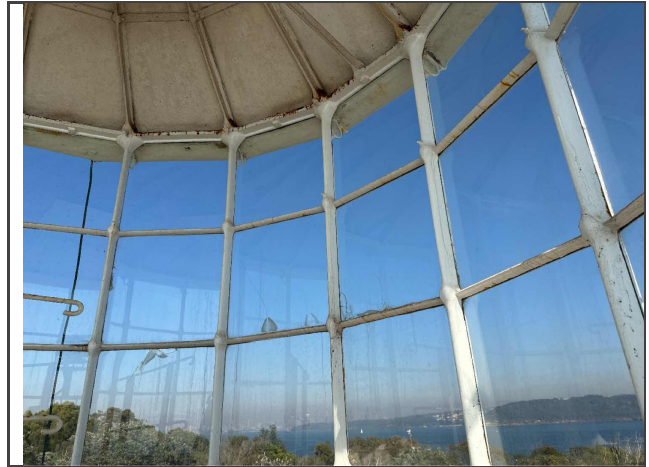
PHOTO: 21	LOCATION: Internal, L2 Lantern room Window frames
MATERIAL: Putty	RESULT: NAD,ORG
