ACKNOWLEDGEMENT OF COUNTRY

AMAC Group and Port Authority of NSW would also like to acknowledge the post contact experiences of Aboriginal peoples who have attachment to the central Sydney area.

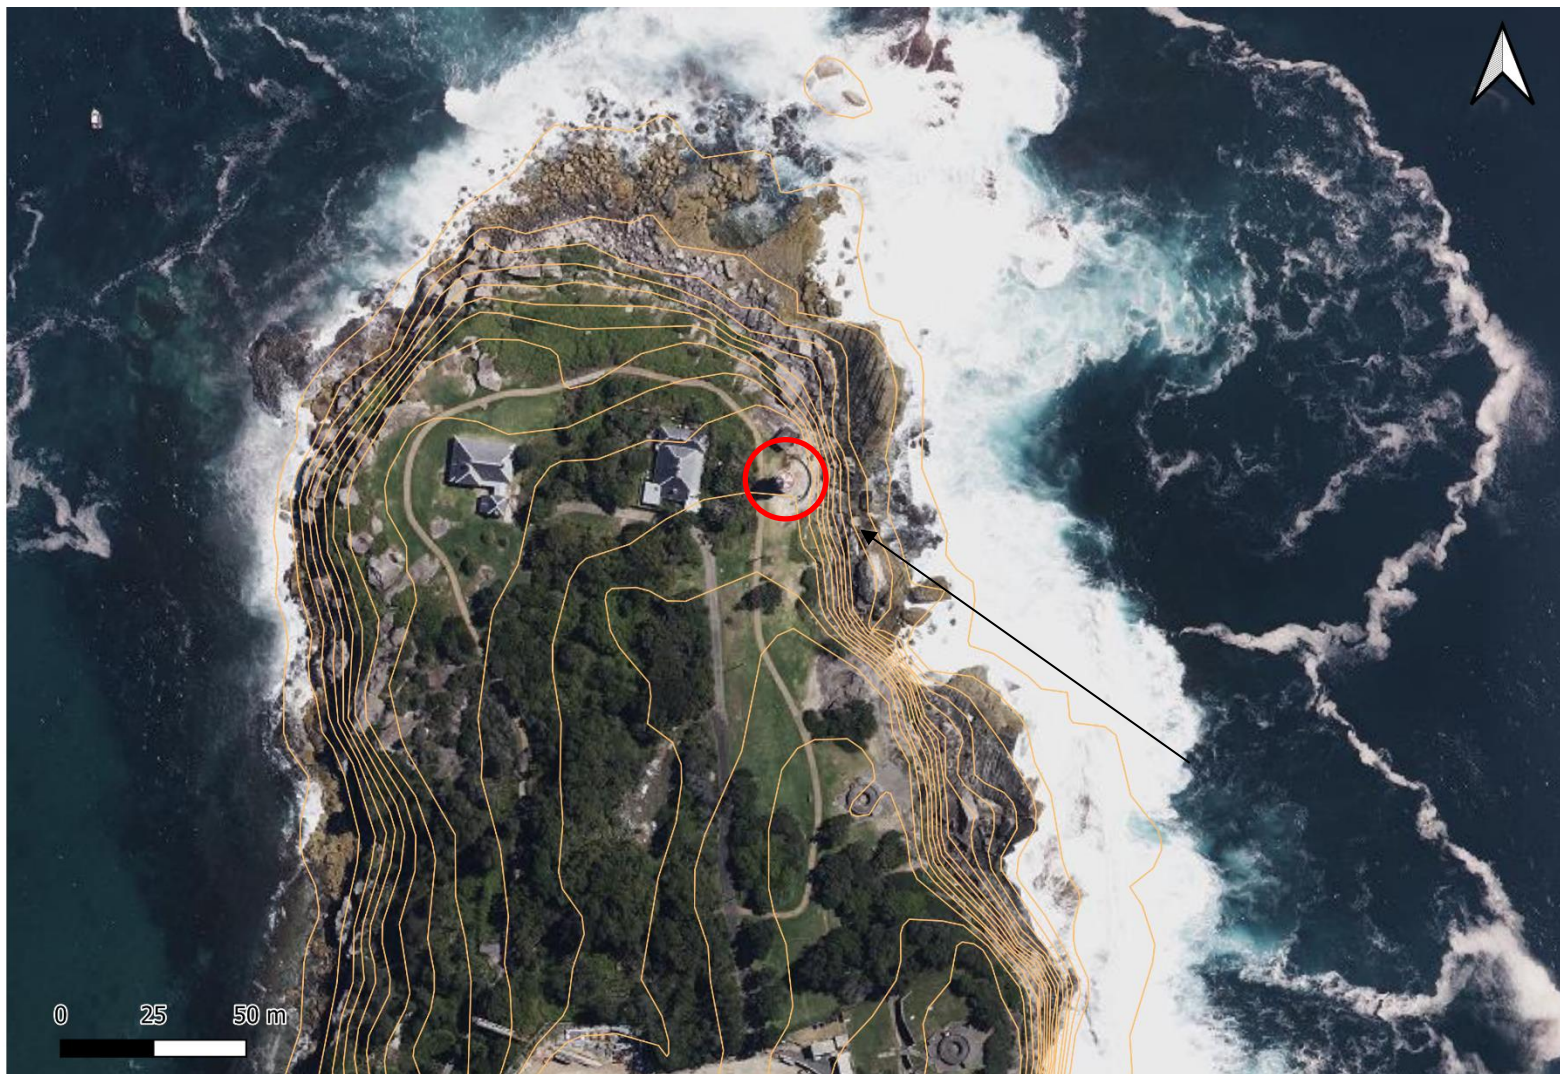
Figure 5-1 Aerial photograph with overlaid 2m contour lines. General site location outlined in red with black arrow. NSW Land Registry Services, Six Maps Viewer, accessed 04/12/2024.

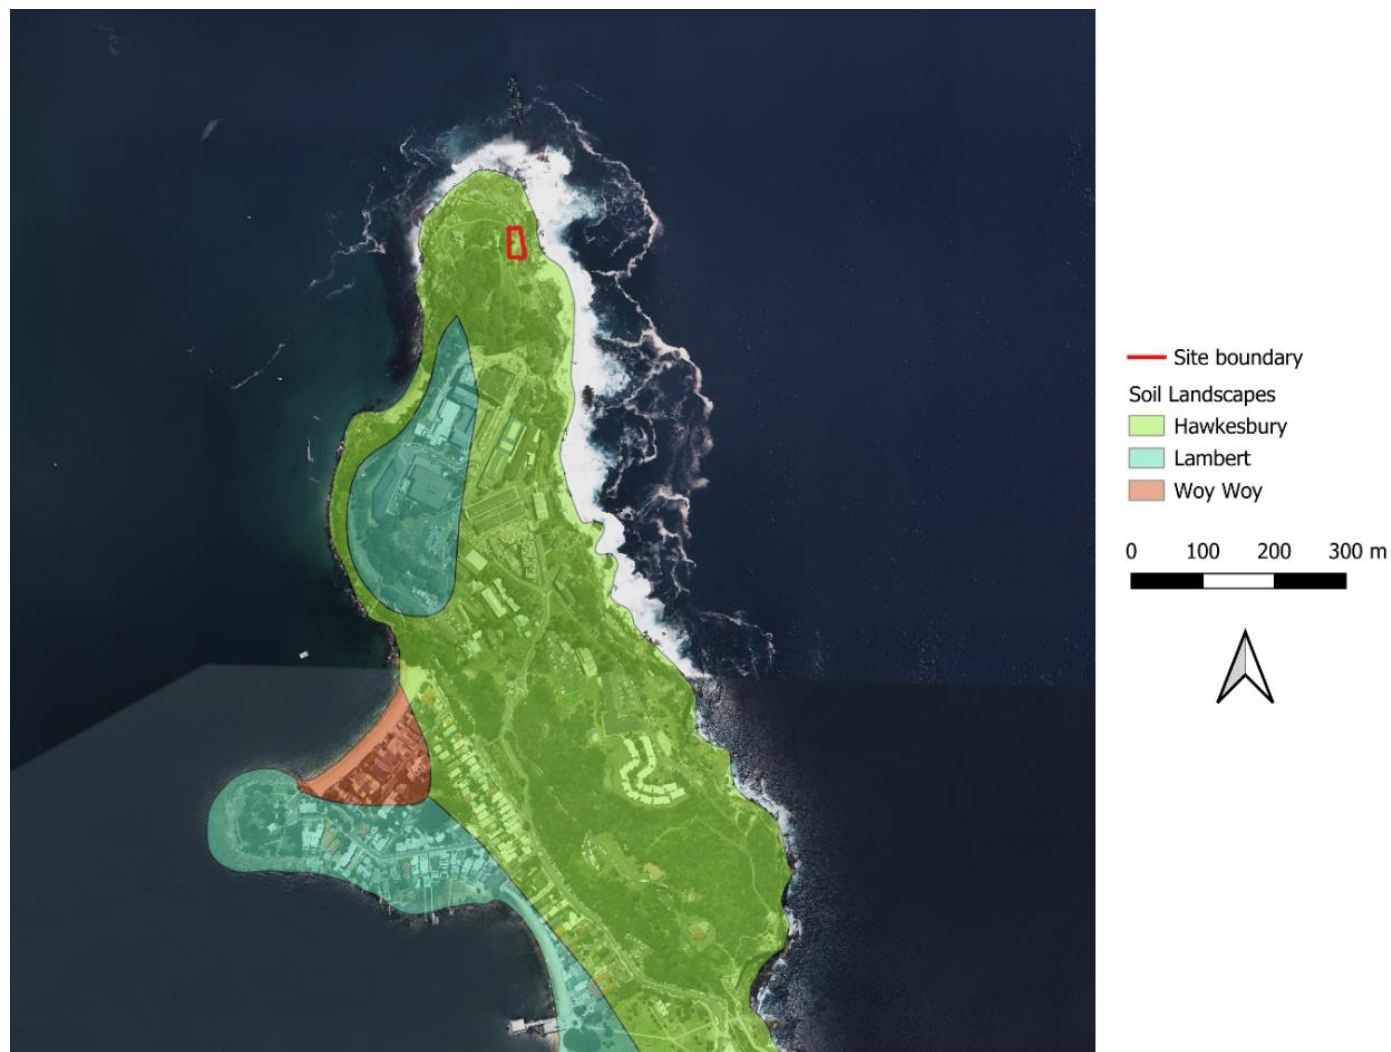
Figure 5-2 Location of the study area outlined in red on soil map.
NSW Government Sharing and Enabling Environmental Data in NSW (SEED), accessed 02/09/2024 and QGIS.

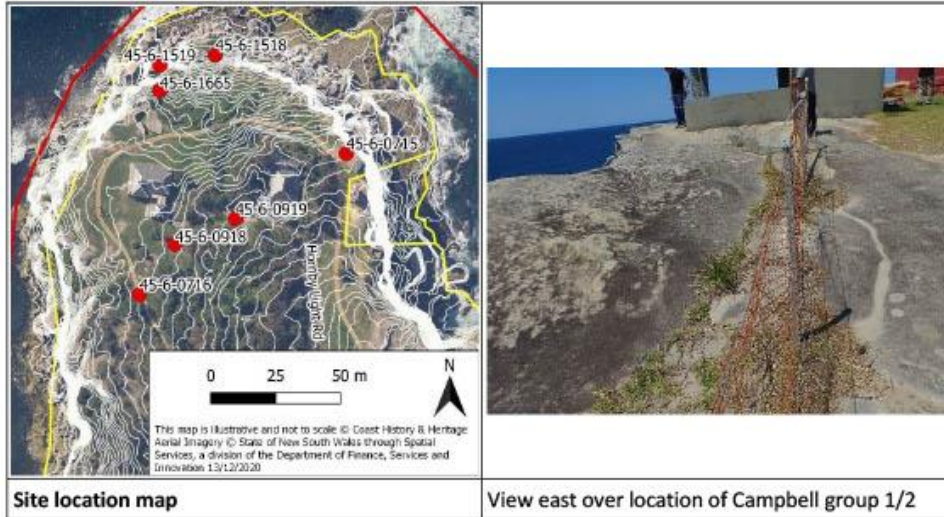
1890s sketch of site 1/1 by Campbell (SLNSW ML D223)
