BASELINE ARCHAEOLOGICAL ASSESSMENT

**Hornby Lighthouse,
Watsons Bay**

Archaeological Management & Consulting Group

March 2024

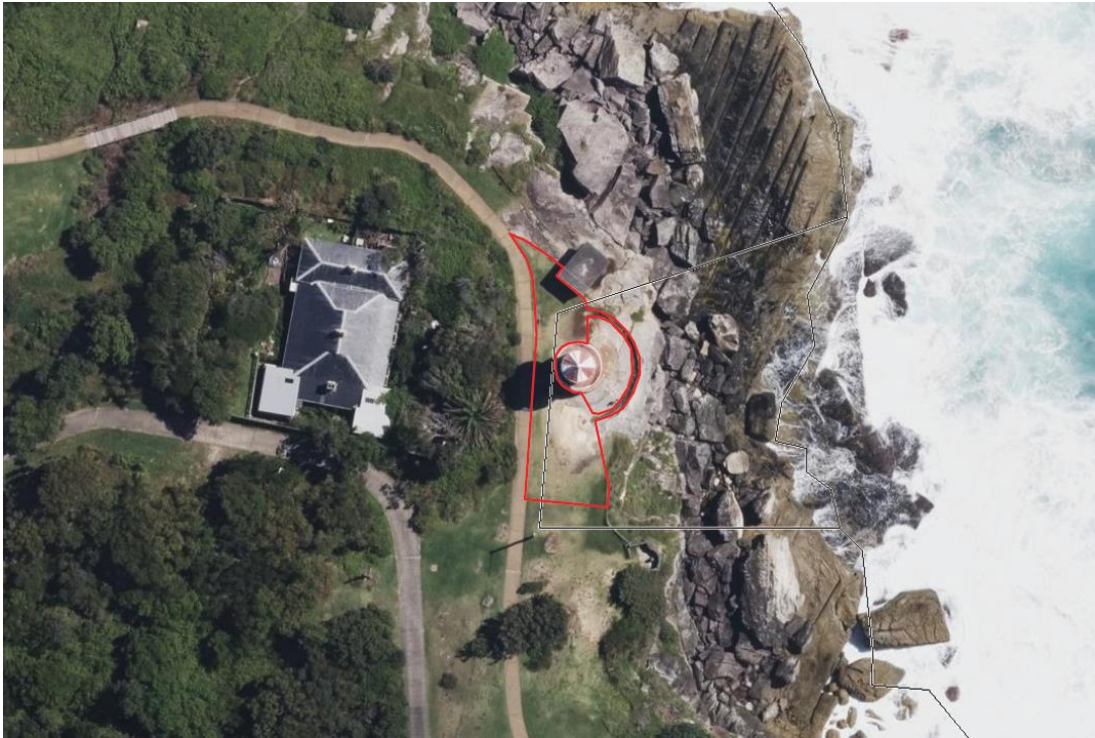
Figure 1.2 Aerial photograph showing the study site and proposed works area outlined in red.
NSW Land Registry Services, Six Maps Viewer, accessed 21/02/2024.

The study site is that piece of land described as Lot 415 DP 752011 (the allotment containing Hornby Lighthouse) and part Lot 1 DP 605078, in the Parish of Alexandria, County of Cumberland (Figure 1.1 - Figure 1.3).

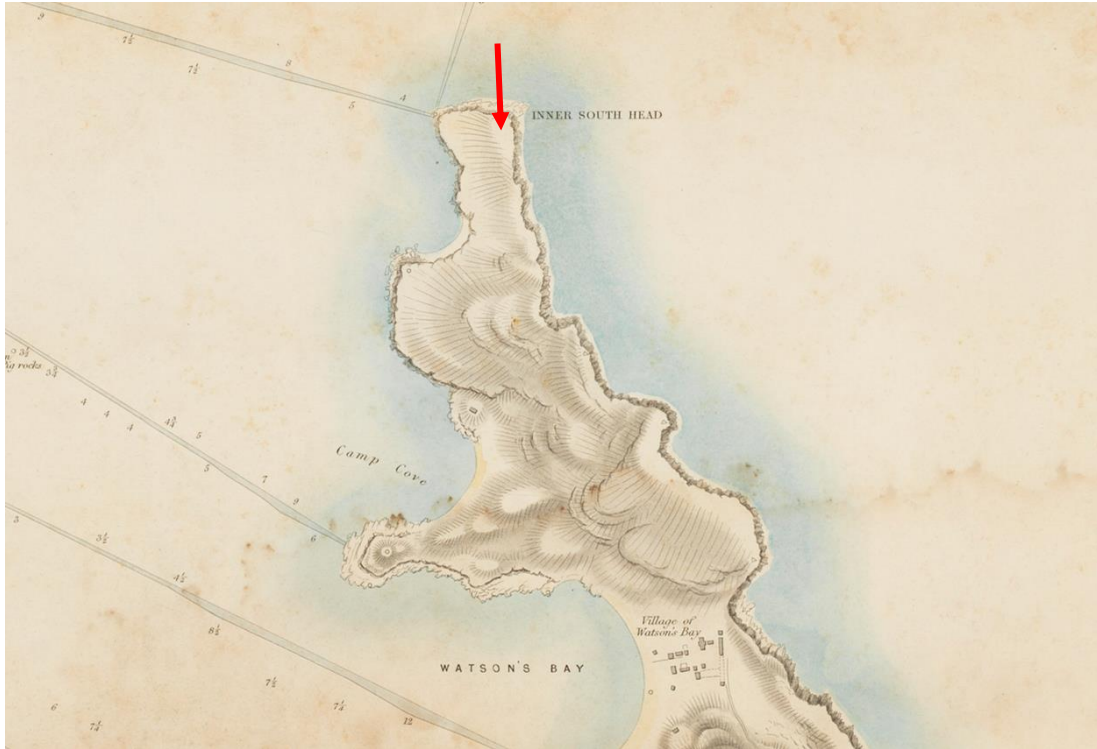
Figure 2.2 1853 trigonometrical survey of Port Jackson. Showing the beginning development of the Village of Watsons Bay with the study area undeveloped. Study site indicated by red arrow. SLNSW FL3702811.

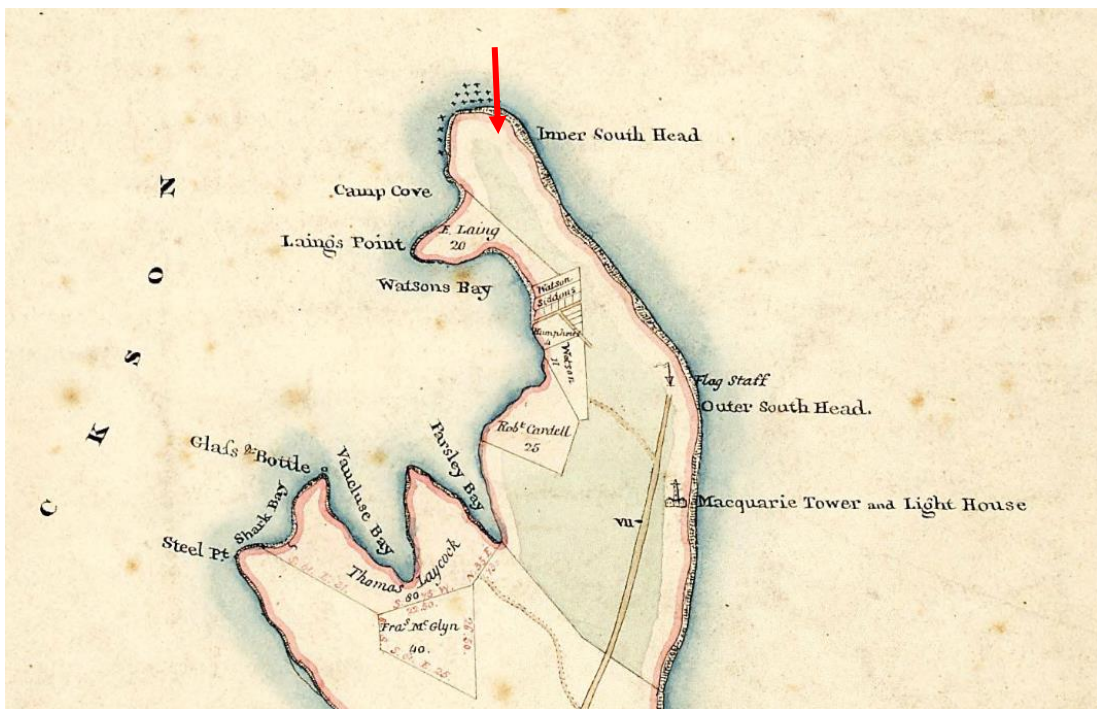
Figure 2.3 Parish map of unknown date showing boundaries of early land grants. Approximate location of study site indicated by red arrow. NSW HLRV.

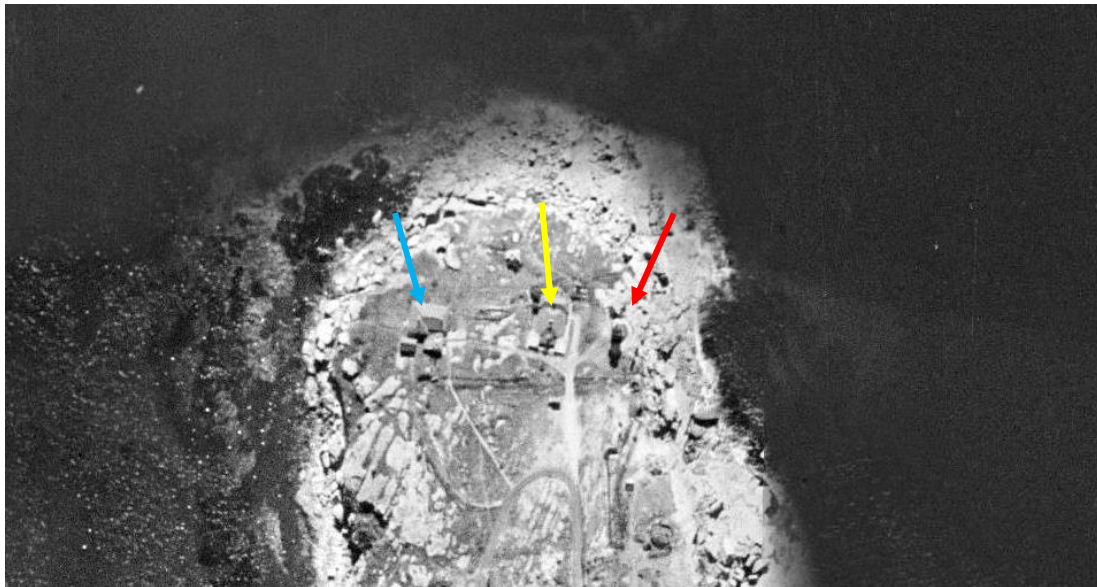
Figure 2.7 1943 aerial. Red arrow = Hornby Lighthouse
Yellow arrow = Assistant Lighthouse Keeper Cottage
Blue arrow = Head Lighthouse Keeper Cottage
NSW Historic Imagery.

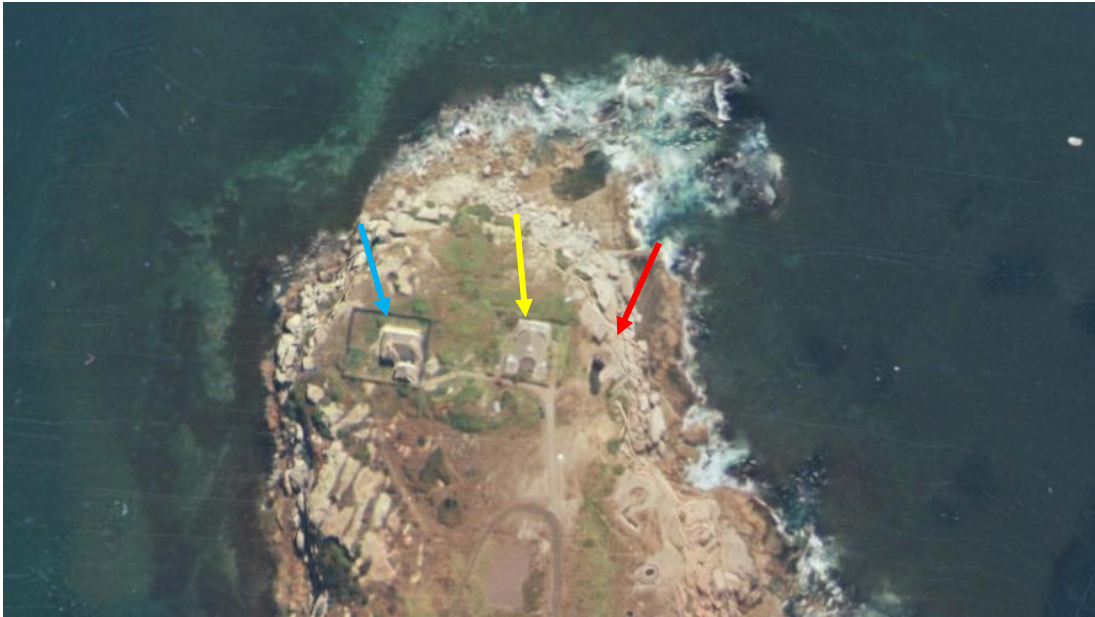
Figure 2.8 1982 aerial.
Red arrow = Hornby Lighthouse
Yellow arrow = Assistant Lighthouse Keeper Cottage
Blue arrow = Head Lighthouse Keeper Cottage
NSW Historic Imagery.

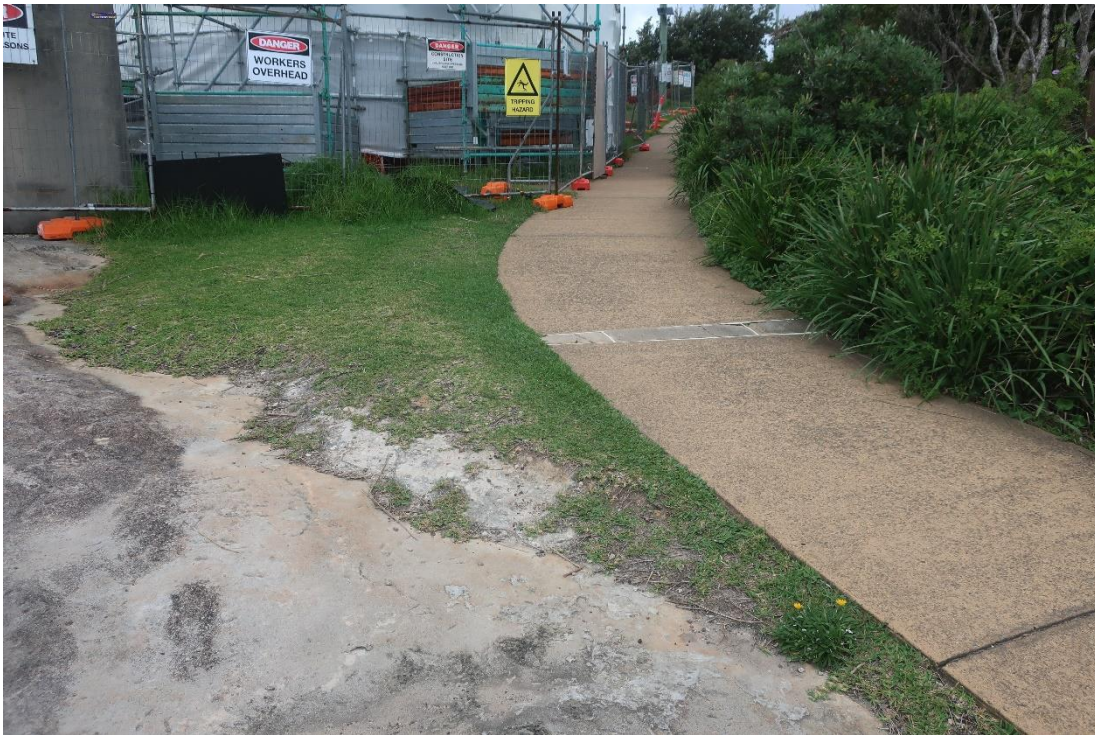
The land generally slopes down from the southwest towards the cliff. Proximity to the cliff has likely prevented the accumulation of fills around the lighthouse both historically and more recently. On the eastern side of the lighthouse there is evidence for the cutting of the bedrock that occurred in order to make the ground level for the construction of the lighthouse.

Figure 3.1 Section of study site north of Hornby Lighthouse, showing small amounts of fill on bedrock. Facing south.
AMAC Group, IMG_7885, 04/03/24.

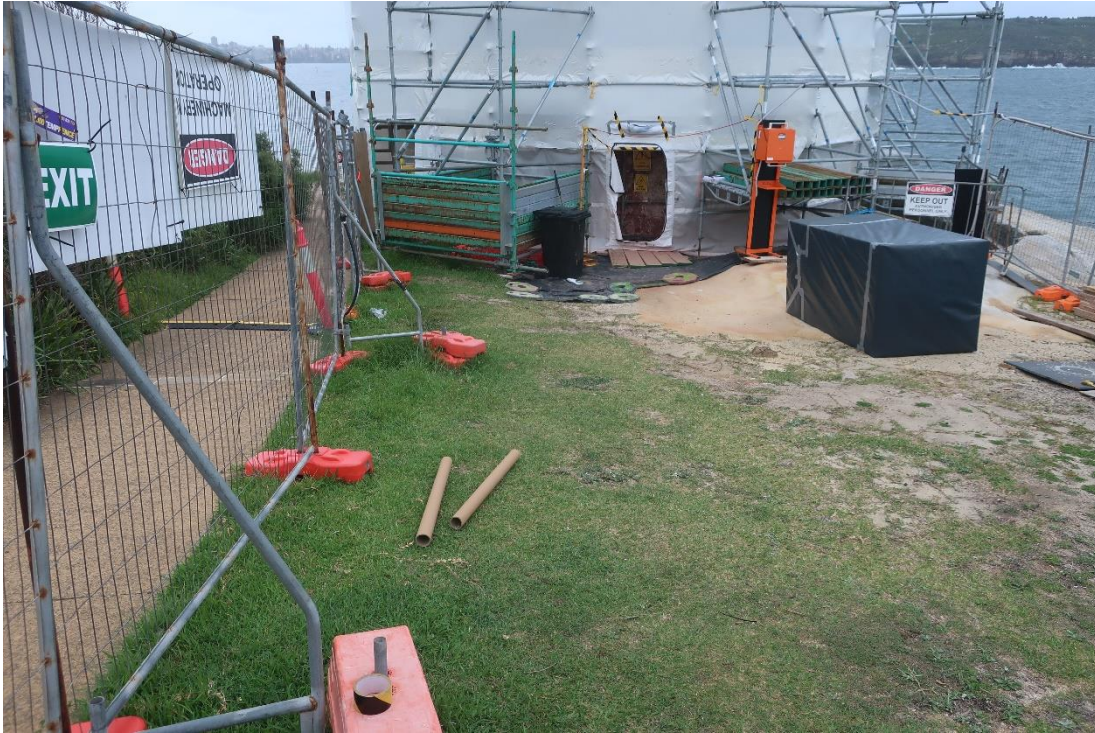
Figure 3.2 Section of study site south of Hornby Lighthouse. Facing north.
AMAC Group, IMG_7889, 04/03/24.

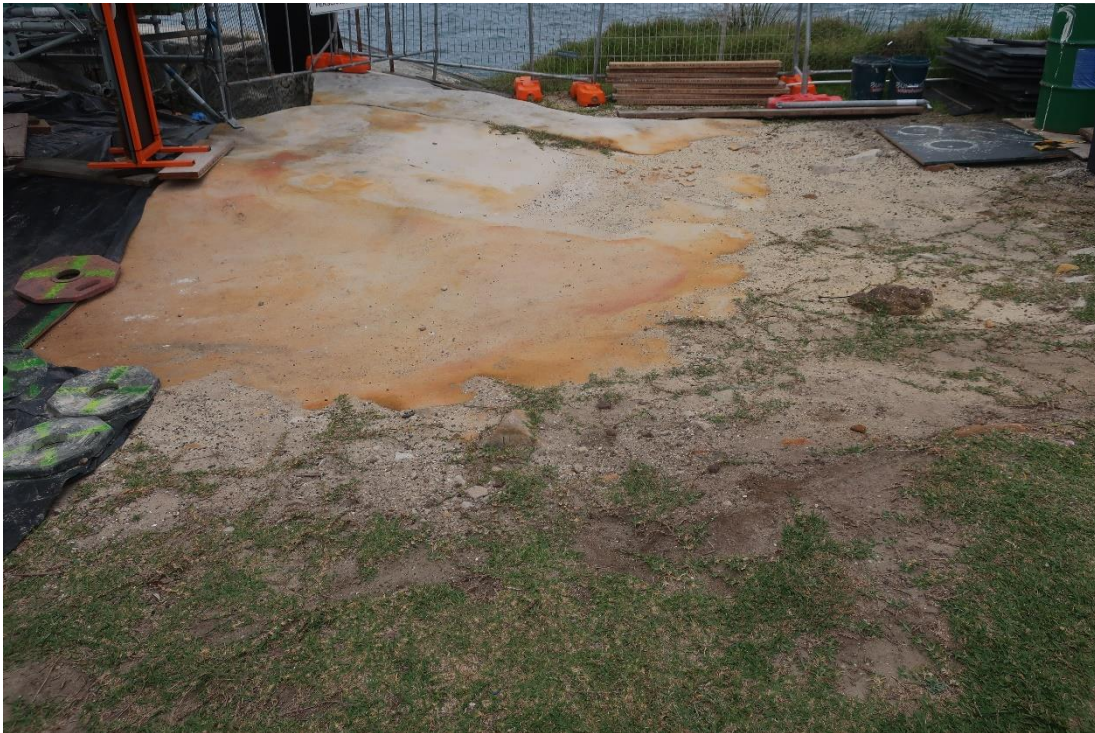
The study site is limited to the land immediately surrounding Hornby Lighthouse. The small area is dominated by the 1858 lighthouse which sits directly on the exposed bedrock. In some places the bedrock has been cut down to create a level surface for the construction of the lighthouse. Hornby Lighthouse is currently undergoing restoration works and is surrounded by scaffolding.

Figure 3.3 Exposed bedrock south of Hornby Lighthouse. Facing east.
AMAC Group, IMG_7902, 04/03/24.

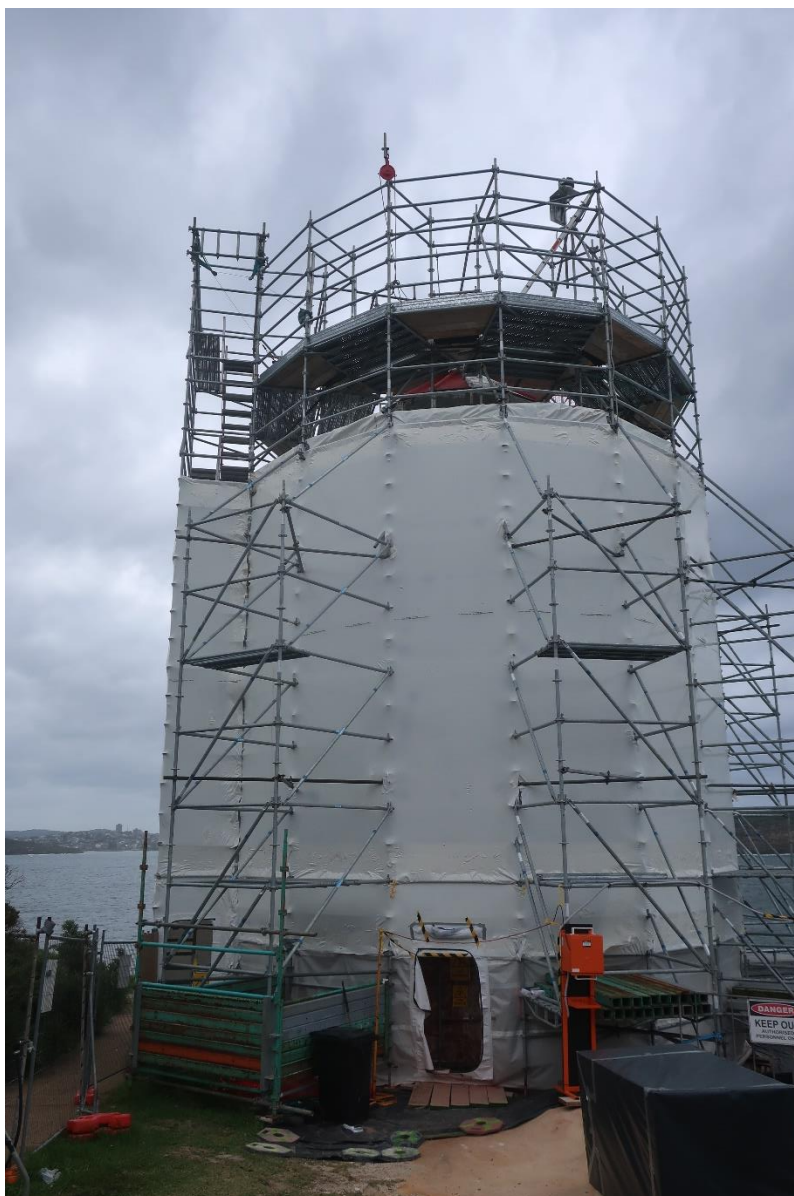
Figure 3.4 Hornby Lighthouse currently surrounded by scaffolding. Facing north.
AMAC Group, IMG_7891, 04/03/24.

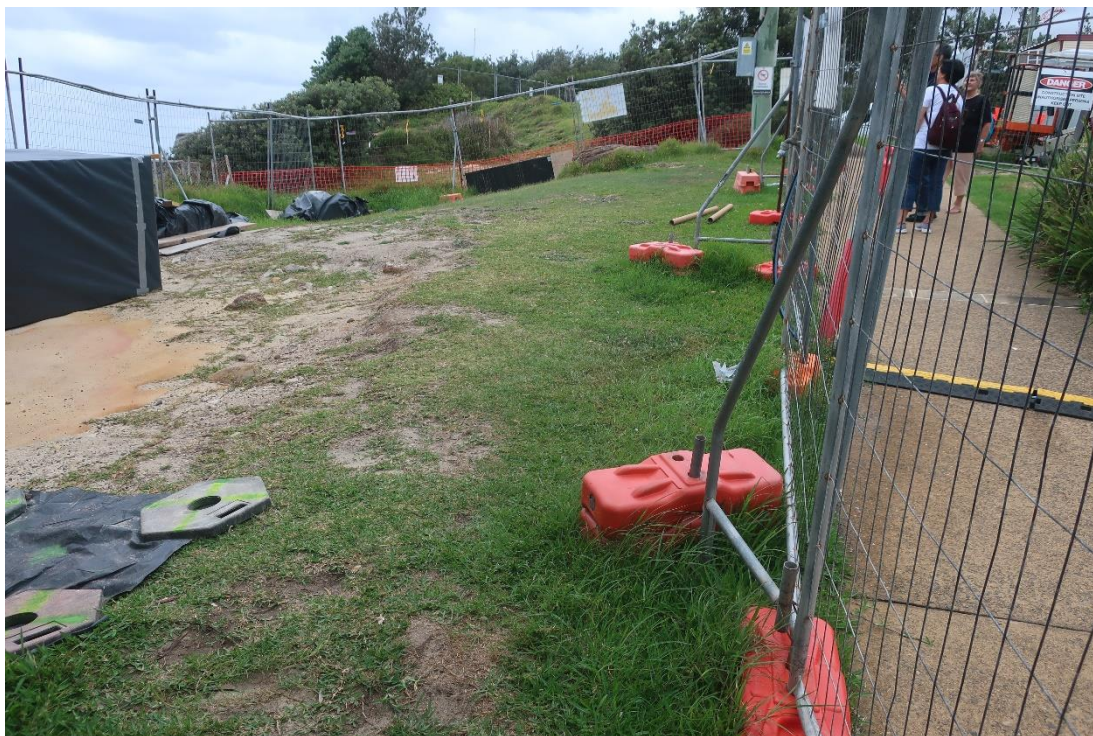
Figure 3.5 Section of study site south of Hornby Lighthouse. Facing south.
AMAC Group, IMG_7898, 04/03/24.

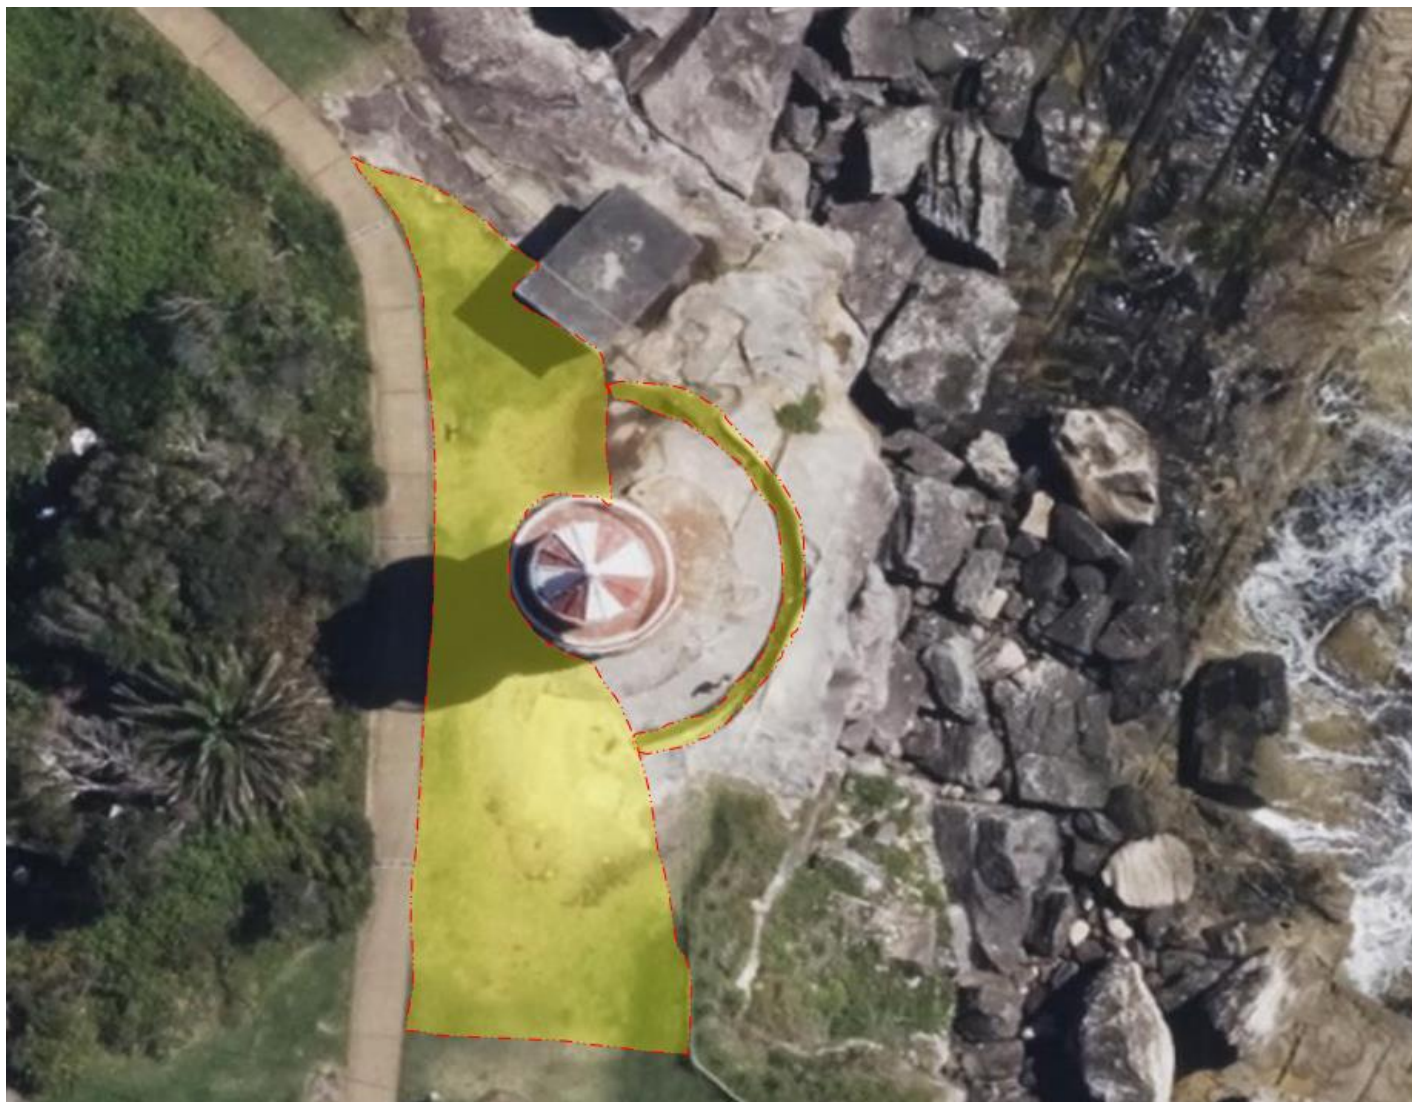
The proposed development seeks to remediate the soils immediately surrounding Hornby Lighthouse and to install a drainage channel and sump to the north of the lighthouse. The red and white paint that currently covers the lighthouse is lead based and over time it has eroded and contaminated the nearby soils. As a matter of public safety, the soils will be excavated between 150mm-250mm and replaced with clean topsoil and turf.

The drainage channel and sump installation is necessary to prevent water from accumulating within the lower ground level of the lighthouse structure and causing further damage. Excavation will occur to the north of the lighthouse for the installation of a pipe and a stormwater pit.

There is also an existing channel in the bedrock that is full of accumulated soil and grass that will be cleared out during remediation works. Work zones are outlined in Figure 5.1 and Figure 5.2 below.

Figure 5.1 Remediation plan showing proposed works area (yellow).
Puch Construction and Building, 2024.

The proposed development requires minor excavation impacts up to 250mm for remediation works when soil is present to that depth. No relics are known to exist within the study site boundary and as a result there will be no negative heritage impact caused by the proposed works.
