**PORT AUTHORITY OF NEW SOUTH WALES**

# **Overseas Passenger Terminal Vertical Transport Upgrade**

## **Review of Environmental Factors**

### PROJECT 311015-00727: Overseas Passenger Terminal Vertical Transport Upgrade - Review of Environmental Factors

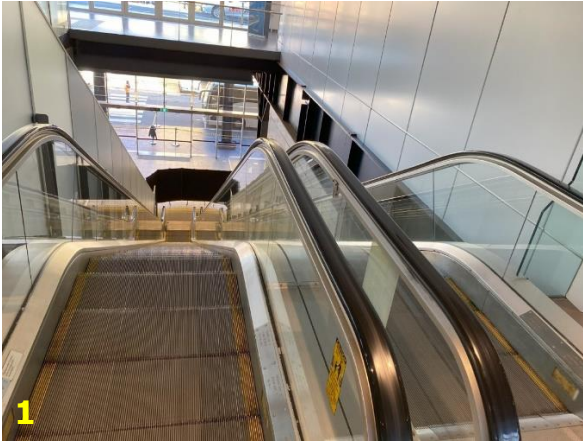
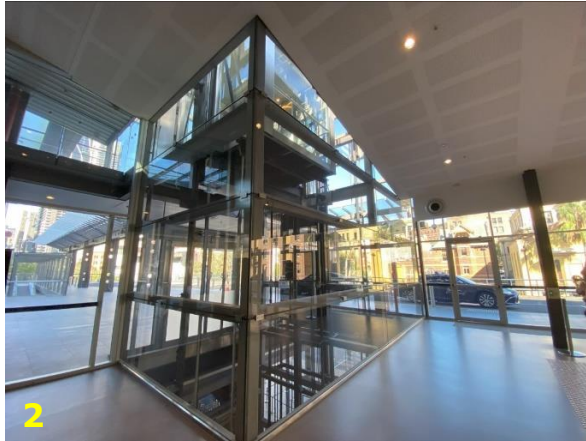
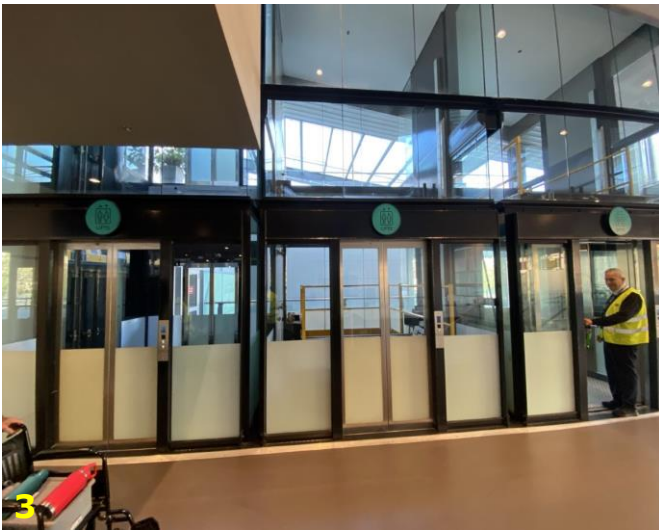
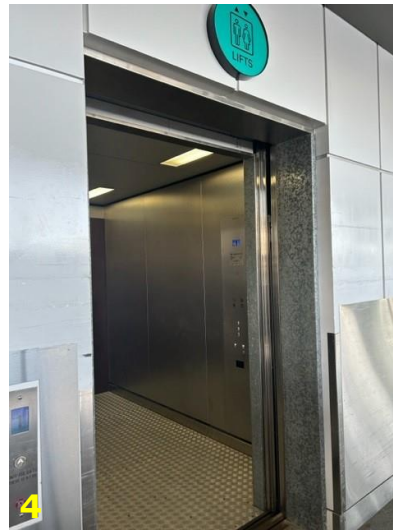
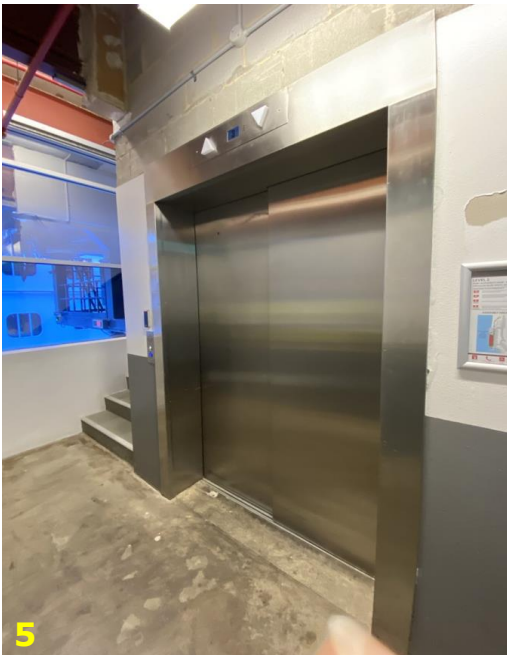
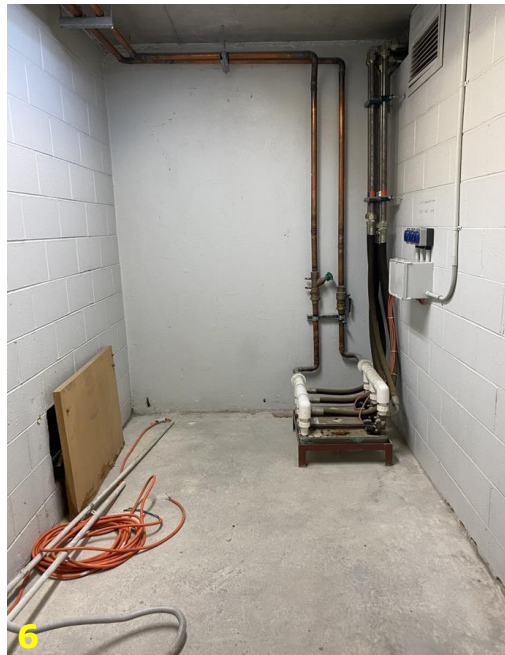
Figure 3-4 Photo 1 Escalators from Level 2 to ground floor (Level 1), Photo 2 Lifts 1-3, view from Level 2 internal, Photo 3 Lifts 1-3 ground floor internal (Level 1), Photo 4 Lift 4 from Level 2 internal, Photo 5 Lift 5 internal and Photo 6 Lift motor room (Source: Port Authority, 2025)

The OPT is a rectangular four storey building located on the western side of Circular Quay. The OPT plays a significant role as an international and domestic Port for cruise ships as well as activating Sydney Harbour and Circular Quay with a range of restaurants and hosting of temporary events. In addition, the OPT provides public access along the foreshore linking Circular Quay to Campbell's Cove. Existing internal lift and escalator layouts are shown in Figure 3-5 and Figure 3-6.

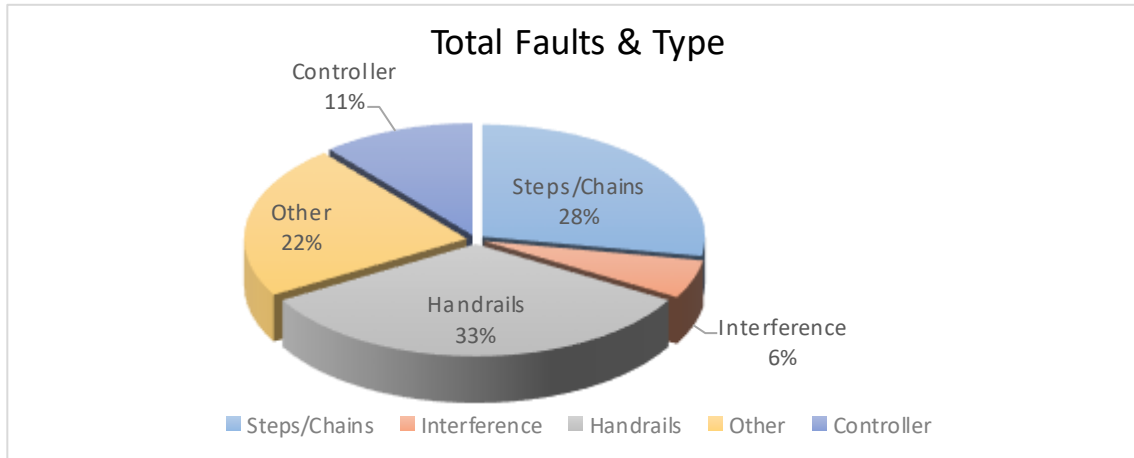
### Escalators and Moving Walks

Lift No.	Steps/Chains	Interference	Handrails	Controller	Other	Total per Lift
Moving Walk 1	2					2
Moving Walk 2	1	1	1		2	5
Escalator 1	2		2		2	6
Escalator 2			1	2		3
Escalator 3			1			1
Escalator 4			1			1
<b>Total</b>	<b>5</b>	<b>1</b>	<b>6</b>	<b>2</b>	<b>4</b>	<b>18</b>

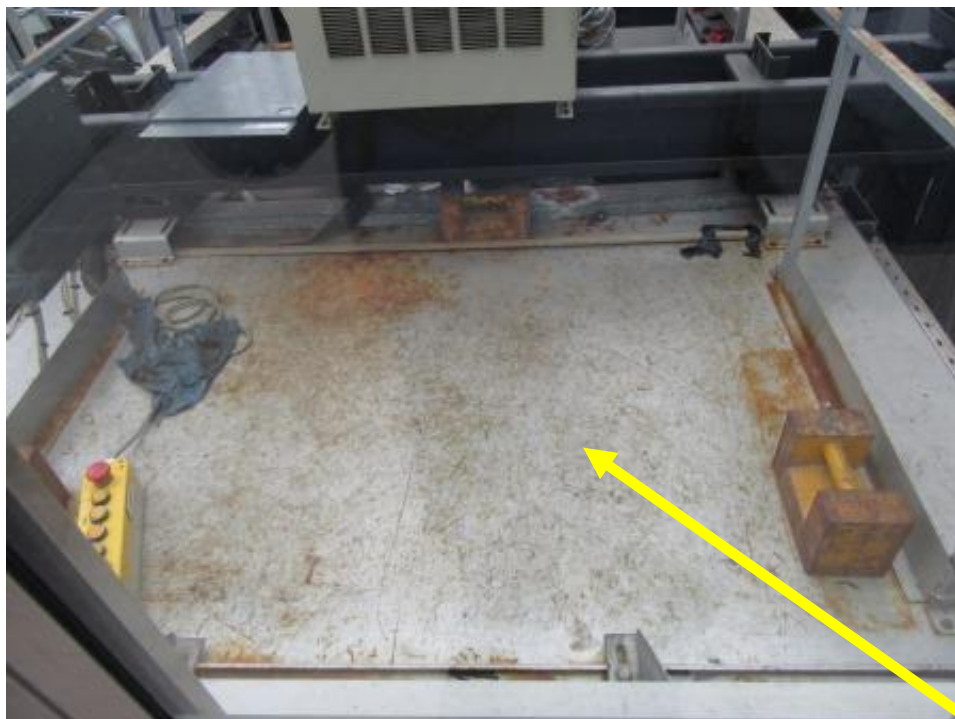
The top of lift 7 showing the surface rust, scratches etc which should be repainted to provide a much better aesthetic

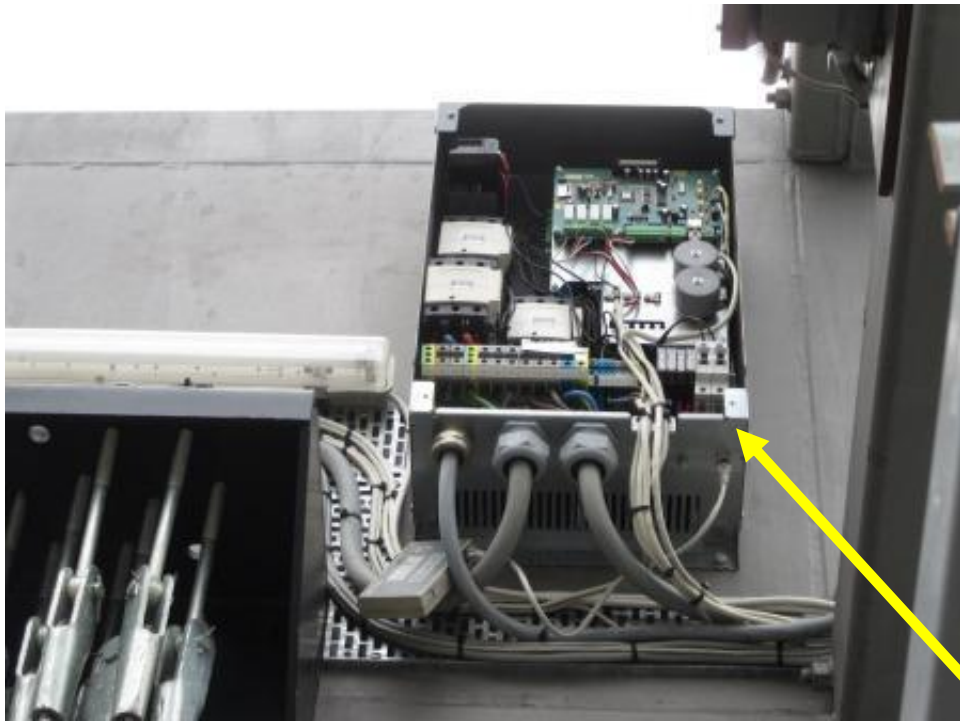
The VVVF drive units and emergency evacuation units on lifts 7-10 are virtually inaccessible and should be relocated

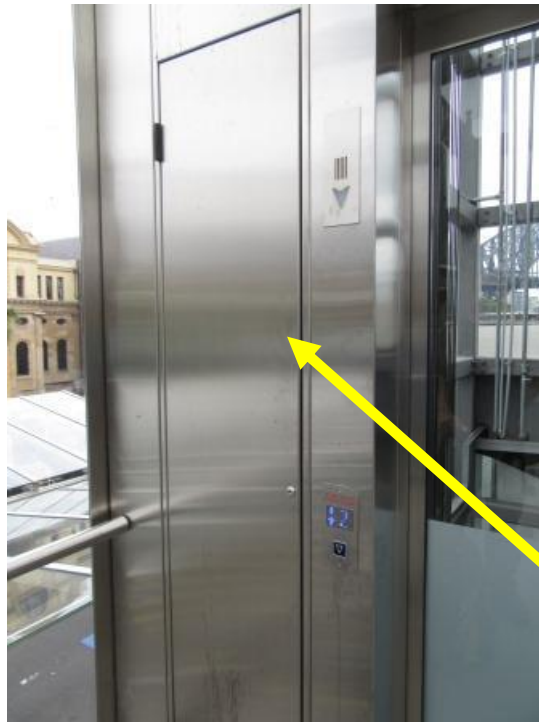
Lifts 7-10. Regulation electrical warning notices are required on the lift controller doors

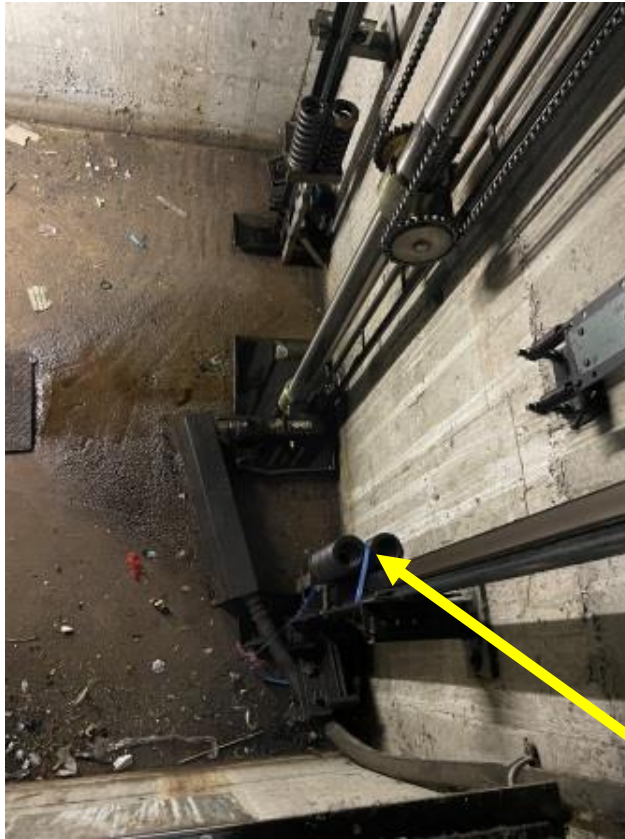
Lift 5 – excess oil needs to be cleaned from the lift pit floor and the floor degreased.  
The hydraulic ram needs new seals.

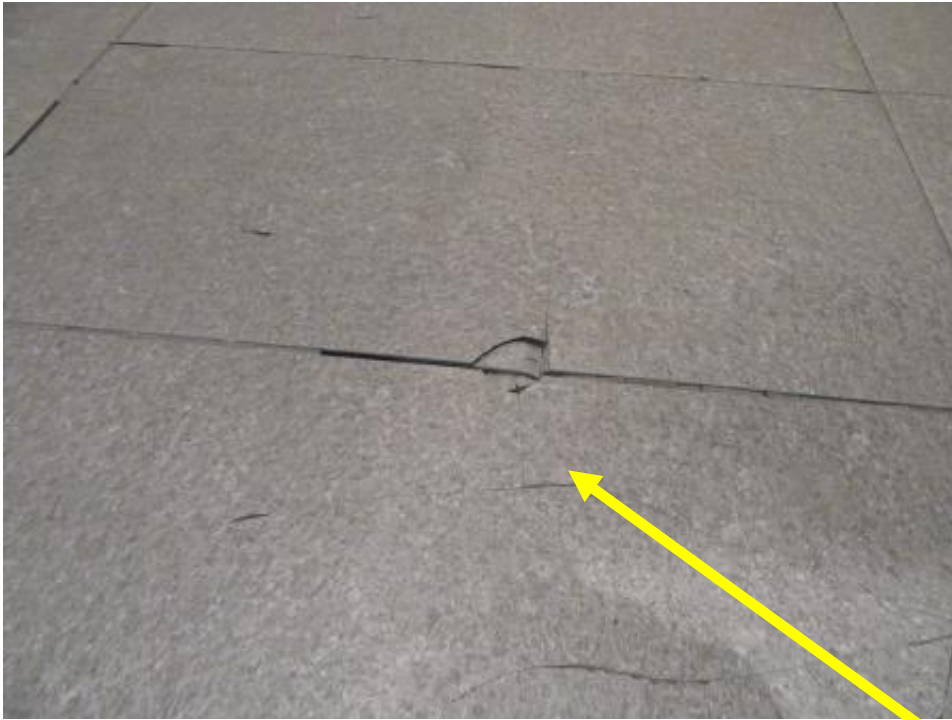
Lift 9 – the lift car floor tiles are damaged and need to be replaced

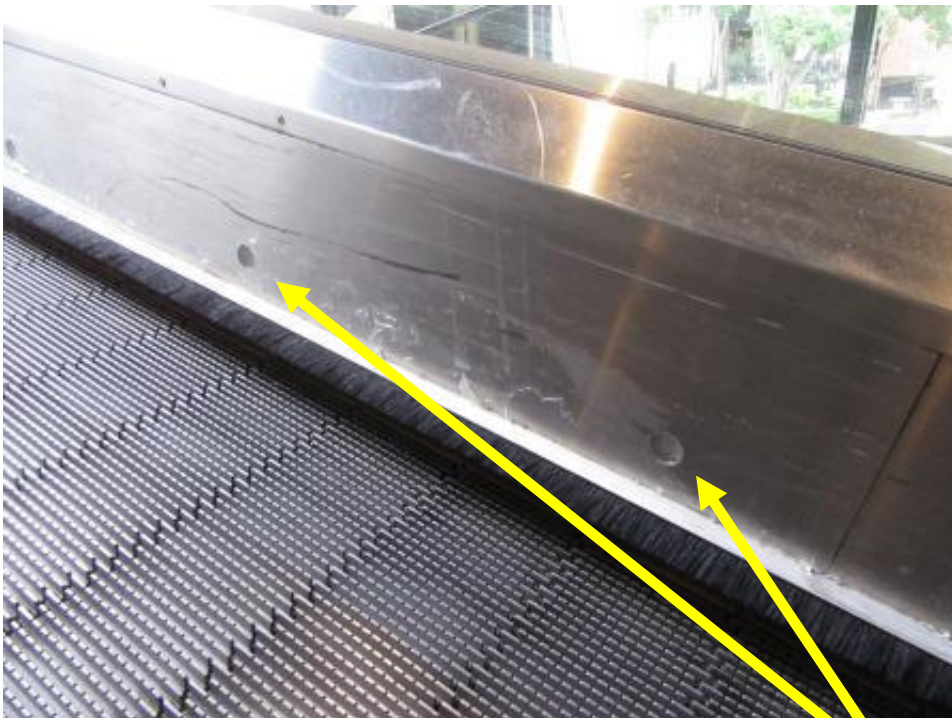
The skirting lighting on the moving walks is inoperative

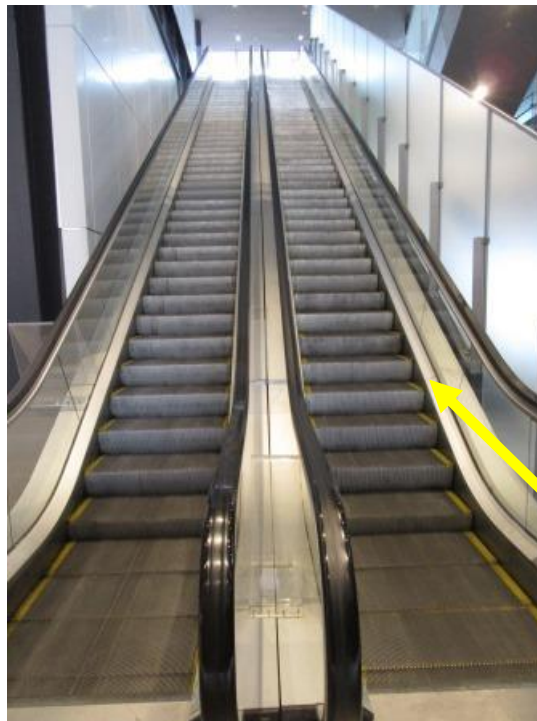
Escalators 1 & 2 were relocated from outside the main building to inside it around 9 years ago. These units are now around 30 years old.

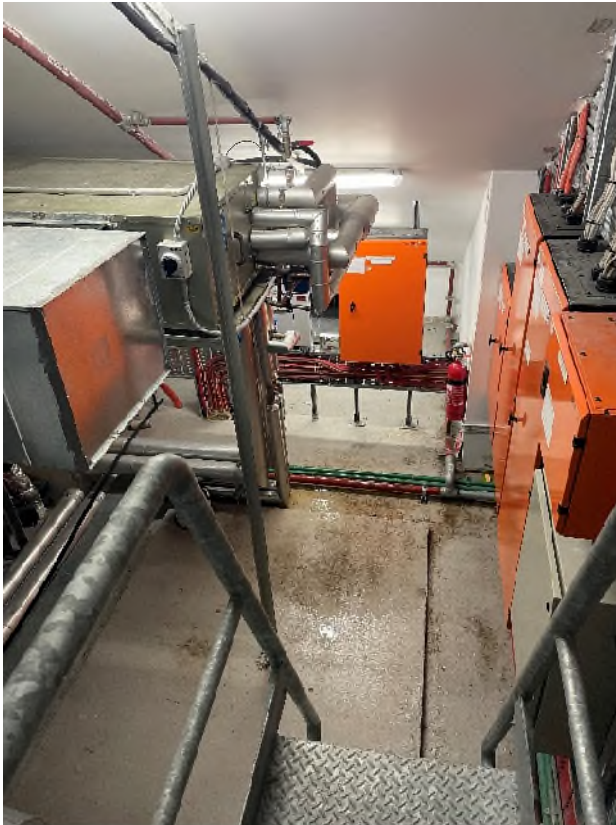
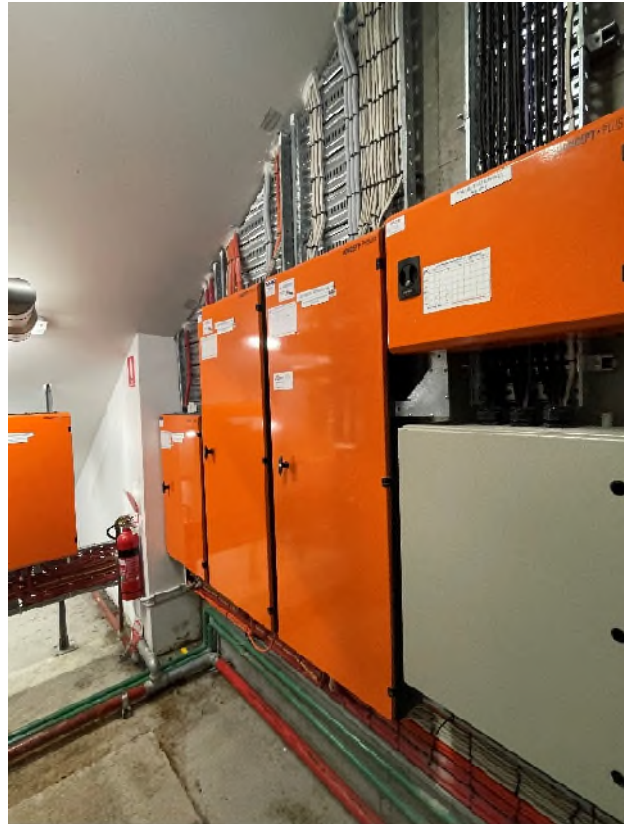
Additionally, the new Escalator 03 was installed directly adjacent to the South of Escalator 01 & 02. This

Escalator serves Level 01, Level 02 and Level 03 and occupies a much smaller footprint than Escalator 01 & 02 as it returns back on itself. This escalator is installed tight to Escalator 01 & 02 and will restrict the ability to manoeuvre the escalators in a Southern direction or utilise any mobile plant to assist with the removal and the new installation.

The 2013 upgrade works to the Overseas Passenger Terminal has seen the introduction of a Plant Room on Level 02 and a Switch Room on Level 01. These two services rooms are located immediately beneath Escalator 01 & 02 and require constant access from maintenance staff to ensure the building remains operational.

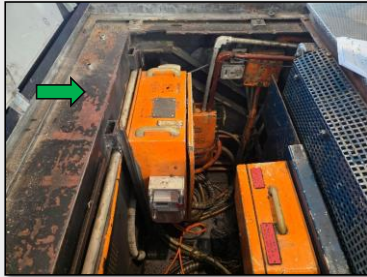
Material Location and Type	Sample ID	Material Status	Friability	Approx. Quantity, Area or Extent	Condition	Disturbance Likelihood	Risk Rating	Recommendations / Comments:	Photographs
Overseas Passenger Terminal, internal, escalator, upper pit, horizontal surfaces - dust	EDP Sample: S-10064.HMA.001-AS001	<b>Non-asbestos (No asbestos detected)</b>	-	-	-	-	-	Nil recommendations.

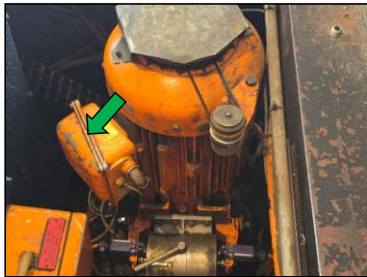
Overseas Passenger Terminal, internal, escalator, upper pit, gaskets to motor - gasket material	EDP Sample: S-10064.HMA.001-AS002	<b>Non-asbestos (No asbestos detected)</b>	-	-	-	-	-	Nil recommendations.

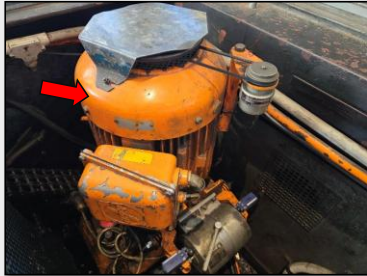
Overseas Passenger Terminal, internal, escalator, upper pit, motor, internal brake pads - friction pads	Not sampled: enclosed unit	<b>Suspected Positive</b>	Non-Friable	1 unit	Fair	Highly Likely	<b>High PI</b>	Confirm status and maintain in current condition if to remain in-situ. Remove under controlled non-friable asbestos removal conditions prior to refurbishment or demolition works by a Class A (friable) or Class B (non-friable) licensed asbestos removal contractor.

Material Location:	Material Type:	Recommendation:
Overseas Passenger Terminal, internal, escalator, upper pit, motor, internal brake pads	Friction pads	Confirm status and maintain in current condition if to remain in-situ. Remove under controlled non-friable asbestos removal conditions prior to refurbishment or demolition works by a Class A (friable) or Class B (non-friable) licensed asbestos removal contractor.
Overseas Passenger Terminal, internal, escalator, upper pit, to plant	Orange coloured paint system	Remove under controlled conditions in accordance with AS/NZS 4361.2:2017 Guide to hazardous paint management, Part 2: Lead paint in residential, public and commercial buildings prior to renovation or demolition works.
Overseas Passenger Terminal, internal, escalator, upper pit, horizontal surfaces	Dust	Accumulated dust and debris was below the adopted AS4361.2:1998 criteria of 1 mg/m <sup>2</sup> . Monitor accumulations of dust and debris with periodic samples to detect any increase in lead content in dust and debris throughout the site where required.

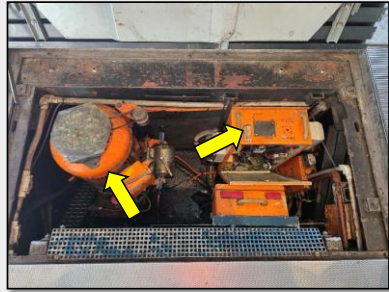
Material Location and Description	Sample ID	Material Status	Approx. Quantity, Area or Extent	Condition	Disturbance Likelihood	Risk Rating	Recommendations / Comments:	Photographs
Overseas Passenger Terminal, internal, escalator, upper pit, to plant - orange coloured paint system	EDP Sample: S-10064.HMA.001-LS001	<b>Lead-containing (3.9 % w/w)</b>	2 m sq	Fair	Highly Likely	<b>High P1</b>	Remove under controlled conditions in accordance with AS/NZS 4361.2:2017 Guide to hazardous paint management, Part 2: Lead paint in residential, public and commercial buildings prior to renovation or demolition works.

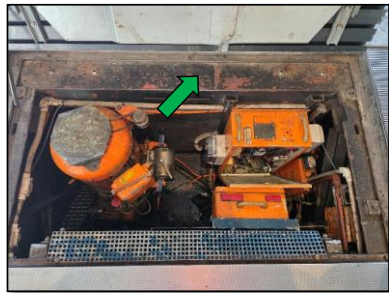
Overseas Passenger Terminal, internal, escalator, upper pit, walls - black coloured paint system	EDP Sample: S-10064.HMA.001-LS002	<b>Non-lead containing (&lt;0.01 % w/w)</b>	-	-	-	-	Not lead-containing paint (≤0.1% w/w) as described in AS/NZS 4361.2:2017 Guide to hazardous paint management, Part 2: Lead paint in residential, public and commercial buildings.

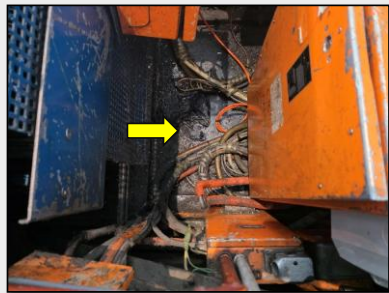
Overseas Passenger Terminal, internal, escalator, upper pit, horizontal surfaces - dust	EDP Sample: S-10064.HMA.001-LD001	<b>Lead-containing (48 mg/m2)</b>	5 m sq	Poor	Highly Likely	<b>Very High P1</b>	Accumulated dust returned above the adopted AS4361.2:1998 criteria of 1 mg/m <sup>2</sup> . Remove the accumulated dust by an experienced contractor under controlled conditions and engage an occupational hygienist to conduct lead dust air monitoring and a clearance inspection.

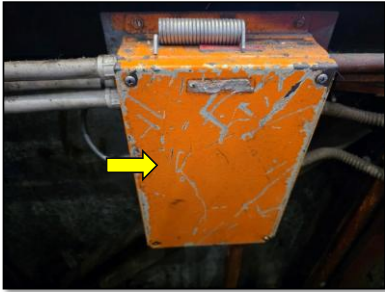
Material Location and Description	Sample ID	Material Status	Approx. Quantity, Area or Extent	Condition	Disturbance Likelihood	Risk Rating	Recommendations / Comments:	Photographs
Overseas Passenger Terminal, internal, escalator, lower pit, to plant - orange coloured paint system	Visually similar to: S-10064.HMA.001-LS001	<b>Lead-containing (3.9 % w/w)</b>	<1 m sq	Fair	Highly Likely	<b>High PI</b>	Remove under controlled conditions in accordance with AS/NZS 4361.2:2017 Guide to hazardous paint management, Part 2: Lead paint in residential, public and commercial buildings prior to renovation or demolition works.

Overseas Passenger Terminal, internal, escalator, lower pit, to plant	Orange coloured paint system	Remove under controlled conditions in accordance with AS/NZS 4361.2:2017 Guide to hazardous paint management, Part 2: Lead paint in residential, public and commercial buildings prior to renovation or demolition works.
Overseas Passenger Terminal, internal, escalator, lower pit, horizontal surfaces	Dust	Accumulated dust and debris was below the adopted AS4361.2:1998 criteria of 1 mg/m <sup>2</sup> . Monitor accumulations of dust and debris with periodic samples to detect any increase in lead content in dust and debris throughout the site where required.

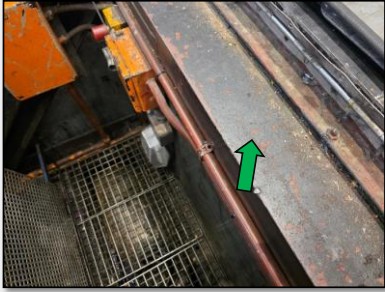
Overseas Passenger Terminal, internal, escalator, lower pit, walls - black coloured paint system	Visually similar to: S-10064.HMA.001-LS002	<b>Non-lead containing (&lt;0.01 % w/w)</b>	-	-	-	-	Not lead-containing paint (≤0.1% w/w) as described in AS/NZS 4361.2:2017 Guide to hazardous paint management, Part 2: Lead paint in residential, public and commercial buildings.

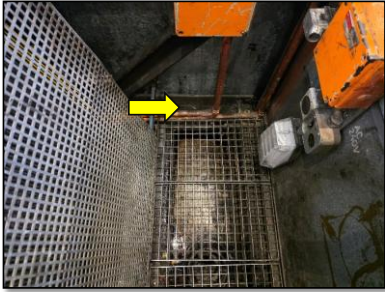
Overseas Passenger Terminal, internal, escalator, lower pit, horizontal surfaces - dust	EDP Sample: S-10064.HMA.001-LD002	<b>Lead-containing (62 mg/m2)</b>	5 m sq	Poor	Highly Likely	<b>Very High PI</b>	Accumulated dust returned above the adopted AS4361.2:1998 criteria of 1 mg/m <sup>2</sup> . Remove the accumulated dust by an experienced contractor under controlled conditions and engage an occupational hygienist to conduct lead dust air monitoring and a clearance inspection.
